**Examination of seismic profiling data for fault
displacements in Hvalfjörður, Iceland**

Greinargerð KG-95-04

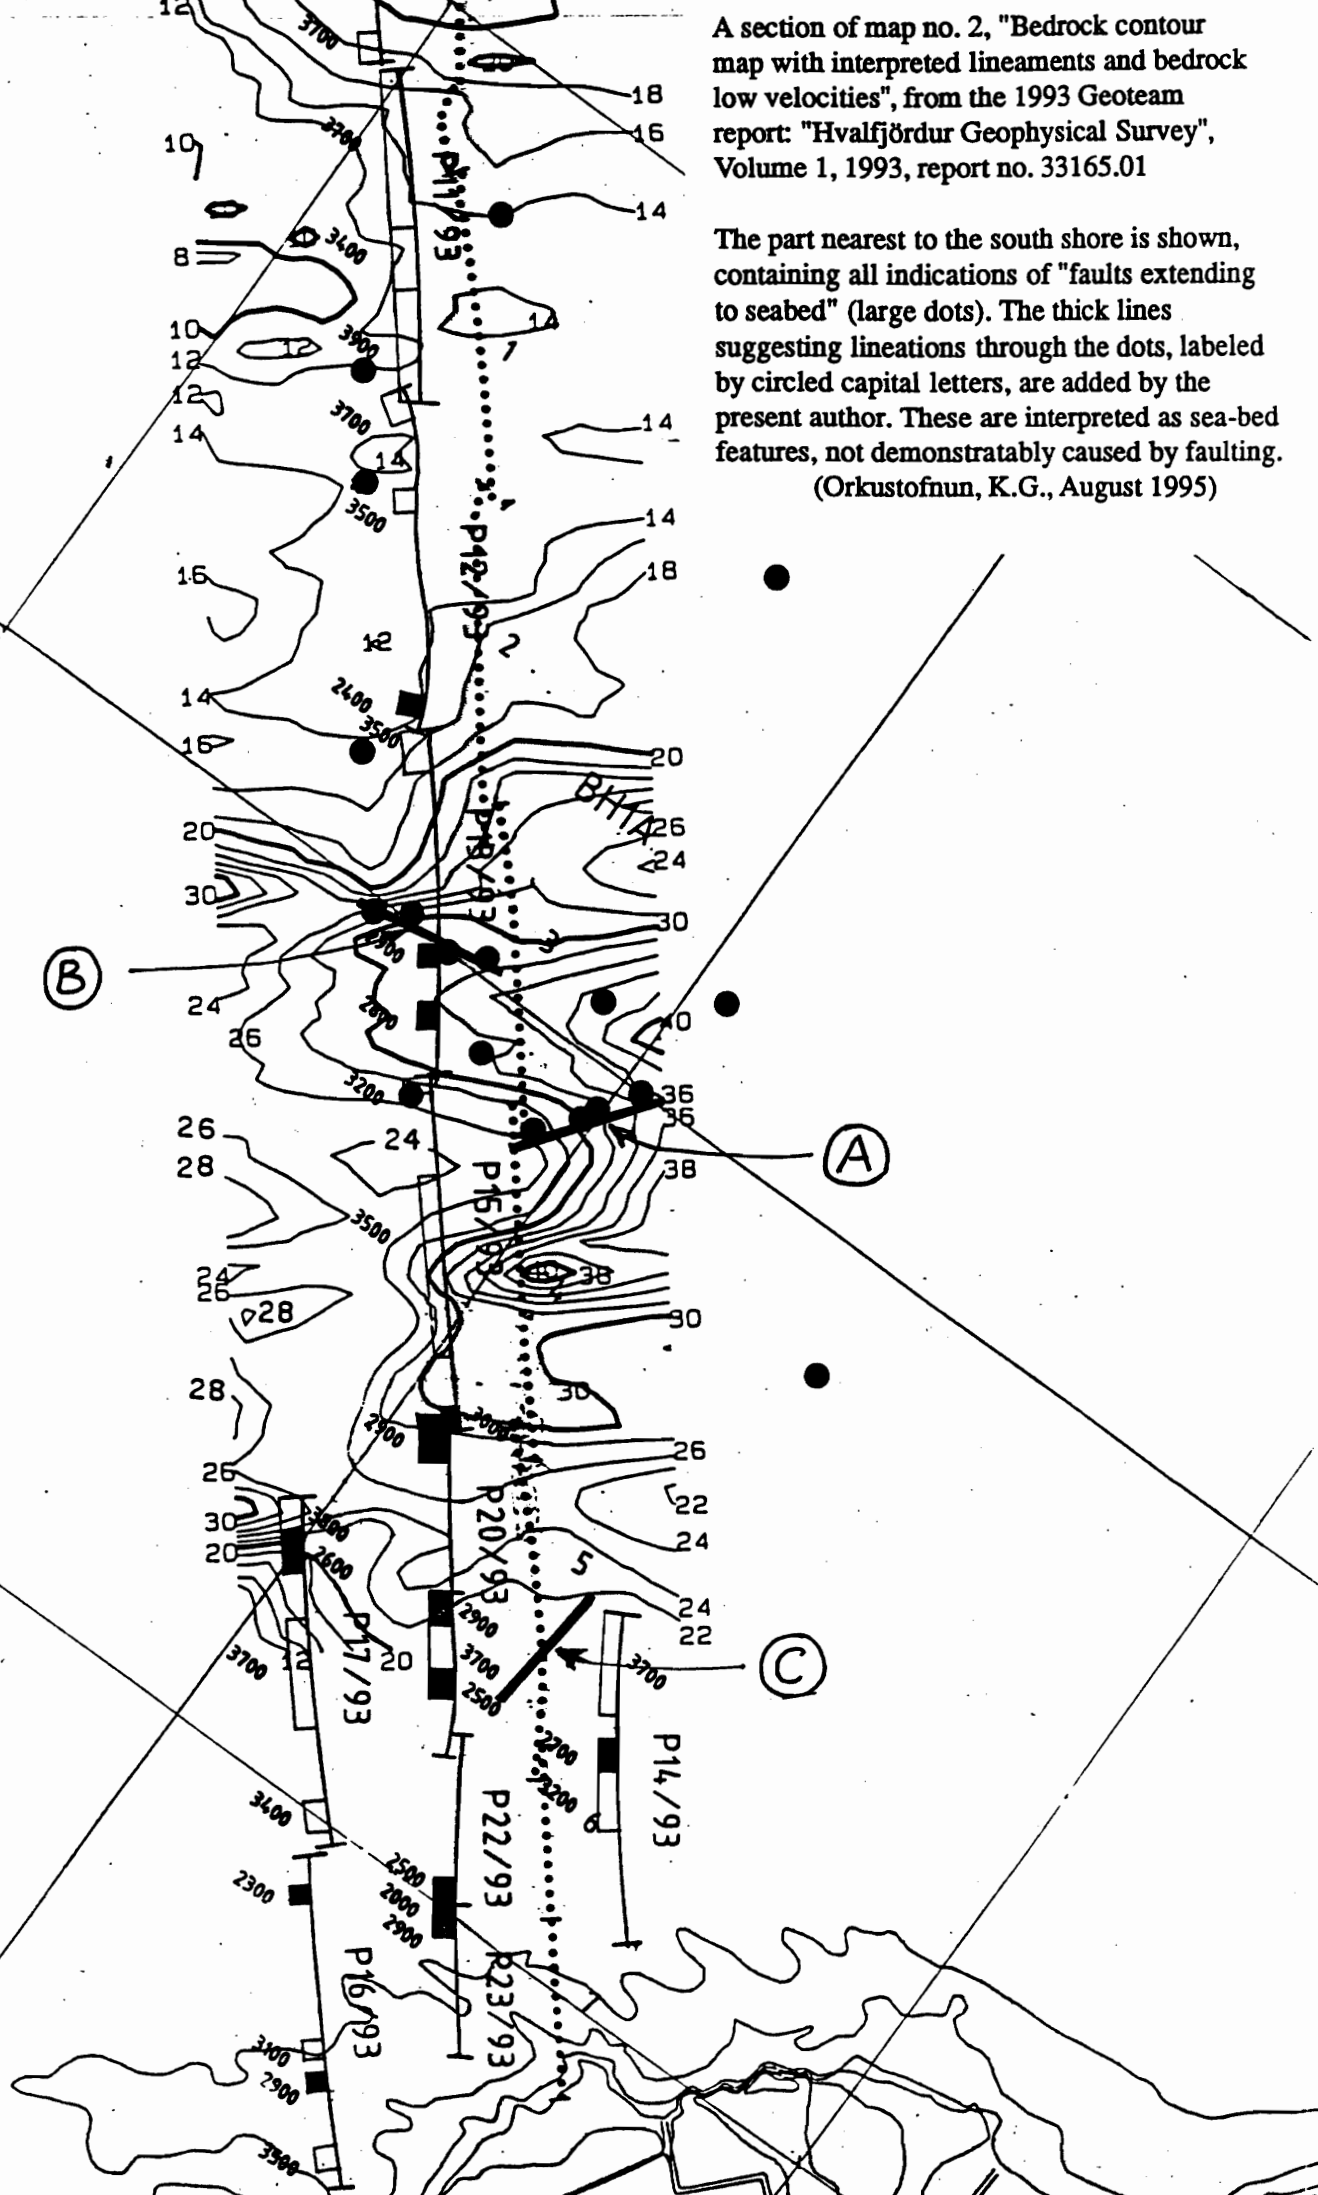
A section of map no. 2, "Bedrock contour map with interpreted lineaments and bedrock low velocities", from the 1993 Geoteam report: "Hvalfjörður Geophysical Survey", Volume 1, 1993, report no. 33165.01

In nearly all of these indicated locations a very slight topographic irregularity is seen in the seabed, steps or undulations. The shapes of these features are not consistently or strikingly "fault-like", nor are their amplitude exceptional or unique for the area. These "bumps" as such can not be taken as a convincing evidence for faulting.

An effort to observe broken and shifted strata below the bumps failed to provide a single convincing case. There are in fact a number of instances where there are apparent shifts in the reflection pattern immediately below the sea-bottom, but these are most likely artifacts in the data. This is due to the long signature of the seismic signal that developed intermittently during the survey. This phenomena causes interference of real and false reflections just below the seabed reflection, suggesting in some cases false faults below surface irregularities. This has not been taken into consideration by the Geoteam interpreter, and it is probably no coincidence that the "fault"-indications are concentrated in that part of the survey area where the long signature character of the seismic source was most pronounced.

For a further discussion of some details the surface features, we refer to the attached figure, which is a copy of a part of the Geoteam map discussed to above (no. 2). The black dots show the locations of the faults or sea-bed features. The distribution suggests that some of these might form elongated nearly linear features on the sea-bed. We have indicated three such possible connections, marked by thick lines and written circled capital letters. Feature (A) is located at the inner edge (south-east edge) of a sand-reef deposit. Other possible causes than faulting could be sea currents shaping the reef, or marks made by sand dredging ships, that operate frequently in

the vicinity. Feature (B) is over a step in the basement. Differential compaction or slumping of sediments over that step could conceivably cause displacements. Feature (C) close to the south shore of the fjord is not shown in the Geoteam map and is added by us. It is slight step in the sea-floor, down on the east side, and has a northerly trend. No suggestions of displacements can be seen in the underlying sediments, which are, however, not suitably stratified. This feature is as likely as any to be a fault.

The part nearest to the south shore is shown, containing all indications of "faults extending to seabed" (large dots). The thick lines suggesting lineations through the dots, labeled by circled capital letters, are added by the present author. These are interpreted as sea-bed features, not demonstrably caused by faulting. (Orkustofnun, K.G., August 1995)
