CORROSION OF STEAM WELL CASINGS  
AND STEAM LINES IN ICELAND

R. #10,367  
PC #3202

August 26, 1953

SAM TOUR & CO., Inc.

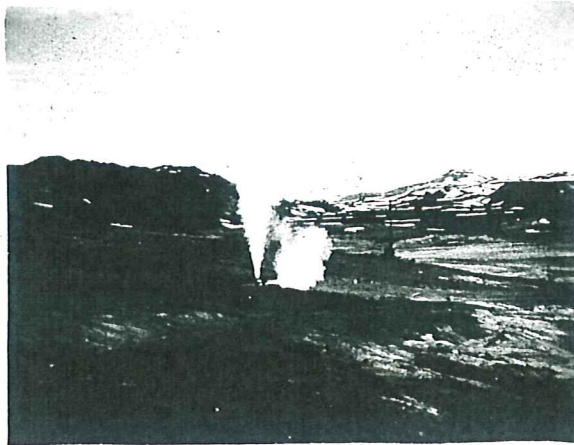
Fig. 1

Going on a short distance from this plant, we arrived at the active steam valley where steam was issuing from dozens of places in the earth and on the side of a hill. Some five or six wells have been drilled in this location. Only one is giving a good delivery of steam. This one is shown in Figure 1. The steam is issuing into the air at considerable velocity and carries some water with it, although not very much. Some steam issues from a

side valve as shown in the illustration. To the rear of the picture showing this steam well is a drill jig where another steam well is being drilled.

Around this area, the smell of hydrogen sulphide is quite intense. In the side outlet of this well was some yellow sulphur and some white salt incrustation. Surrounding the valve on the top of the well casing was a white crust of residue. Samples of the white scale around the 6-inch valve on this steam well and of the white and yellow deposits in the side blow-off of this well were taken for analysis.

There is a possibility, although faint, that aluminum might be satisfactory. In order to determine whether or not aluminum would be satisfactory, a short piece of about a 2-inch diameter aluminum pipe was found by the local man who tends these steam wells. This short piece of pipe, approximately 15 inches long, had a small aluminum casting on one end of it. The writer hung this piece of aluminum pipe and casting in the horizontal

blow-off trench in the casing of the steam well #3 shown in Fig. 1. It is hoped that this piece of aluminum pipe and this aluminum casting will stay in place long enough to be able to give some indication as to whether or not aluminum pipe would be suitable for handling the steam and the water from this steam well. If aluminum will stand up, there is a possibility that steel casings could be metallized with aluminum and sealed with water-glass for this service. Mr. Lindal pointed out that he had tried metallizing with aluminum and sealing with water-glass in a 10% sulphuric acid solution, but that this did not stand up in such a high concentration. It is quite evident that no such high concentrations are reached in actual practice. It is doubted that in actual practice, the concentration would ever reach the equivalent of 1/10th of 1% of sulphuric acid and probably largely sulphurous rather than sulphuric acid.

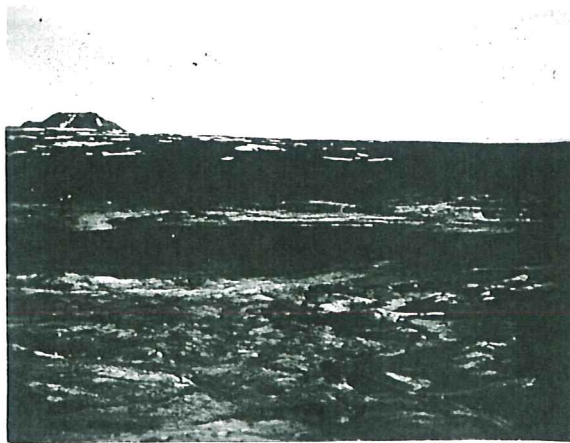
Fig. 2

Figure #2 is a general view of this ground showing steam issuing in hundreds of places. The large mud pool where steam well #1 disappeared is just left of center of this picture. In addition

to this steam rising in the valley area, steam is also rising from many fissures in the side of the hill to the left of the steam well #3 shown in Fig. 1.

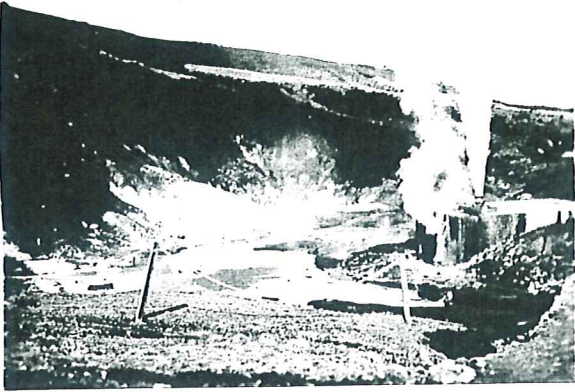
Fig. 3

A number of wells have been drilled at Krisuvik. The principal producing well is #14 as shown in Fig. 3. This #14 well has been emitting steam for approximately five years at a reported rate of about 20 tons per hour. The analysis of the steam, the gas carried with it and the water carried with it as reported by Mr. Baldur Lindal is shown in Table I. It will be noted that the volume of gas coming with the steam from these wells in Krisuvik is less than half the volume of gas coming with the steam in the wells in Northern Iceland. Also it will be noted that the percentage of hydrogen sulphide in the gas is less in these southern wells than in the northern wells. Nevertheless, there is sufficient hydrogen sulphide present to oxidize and react with oxidized sulphur to deposit free sulphur. The yellow markings of free sulphur are evident around these wells which have been drilled and around the various spots where steam is issuing from crevices in the ground where wells have not been drilled. Such steam can

The large valve on the top of the concrete head for steam well #14 shows severe corrosion of the body. The valve seems to be one with a cast steel body. The inside trim is not known. Some of the heavy scale on the surface of this valve body was taken as a sample for analysis and is shown as sample #5 in Table II. It will be noted that this scale consists of iron plus silica deposit from the water. Also this scale contains some sulphates and some chlorides. The analysis of the water entrained with the steam from #14 well in Krisuvik is shown in Table I. Attention is called to the very high chloride content of this water.

Steam well #14 at Krisuvik has been proven to be a steady producer. The amount of steam issuing and the pressure at which the steam is issuing is sufficient to warrant the installation of a steam turbine generator unit to produce electrical power. The water could be separated from the steam in a centrifugal or cyclone type of separator. The problem becomes one of obtaining a steam turbine built of suitable material to give an economical service life when operated with steam carrying a gas high in carbon dioxide and hydrogen sulphide. There is no way known to remove these gases from the steam. Steam turbine practice throughout the world has shown that carbon dioxide in steam is objectionable from the standpoint of life of turbine blades. When hydrogen sulphide is present in addition to carbon dioxide, the conditions are worse. In some parts of Italy, power is being produced from natural steam. It is understood that the steam in Italy also carries some carbon dioxide and hydrogen sulphide. It is believed that the experiences gained to date in these installations in Italy would be applicable to the problem of harnessing the steam in Krisuvik for the production of electrical power.

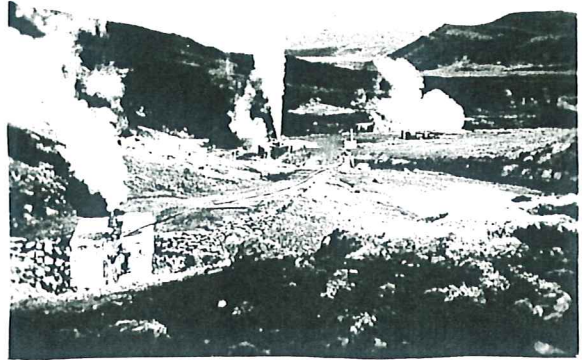
be seen coming from the ground in the center of Fig. 3. Fig. 4 is a general view showing a number of the steam wells in action. Well #14 is in the center of the picture. Fig. 5 is a closeup picture of the steam coming from a natural opening in the earth where the water and mud is boiling continuously. Fig. 6 is a view from a distance of the various steam wells in this area. Well #14 is in the center of the picture; #19 is to the far right.

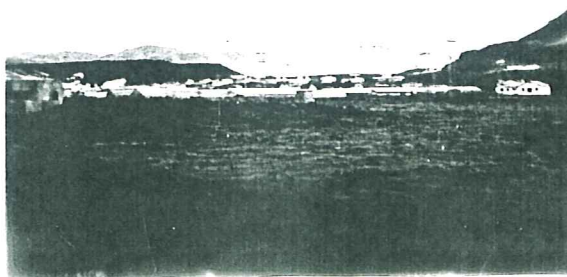
On May 29, 1953, a visit was made to the Hveragerdi area in company with Mr. Gunnar Bodvarsson. In this area many steam wells are producing small quantities of steam at low pressure and quantities of boiling hot water. The steam and hot water is used for heating of the many greenhouses in the area. Fig. 7 is a view of a large number of greenhouses in this area.
