A PRELIMINARY STUDY OF EROSIONAL
FEATURES IN VATNSFELL - DIVERSION

Guttormur Sigtjarnarson, geologist, NEA

Reykjavik, August 1973.

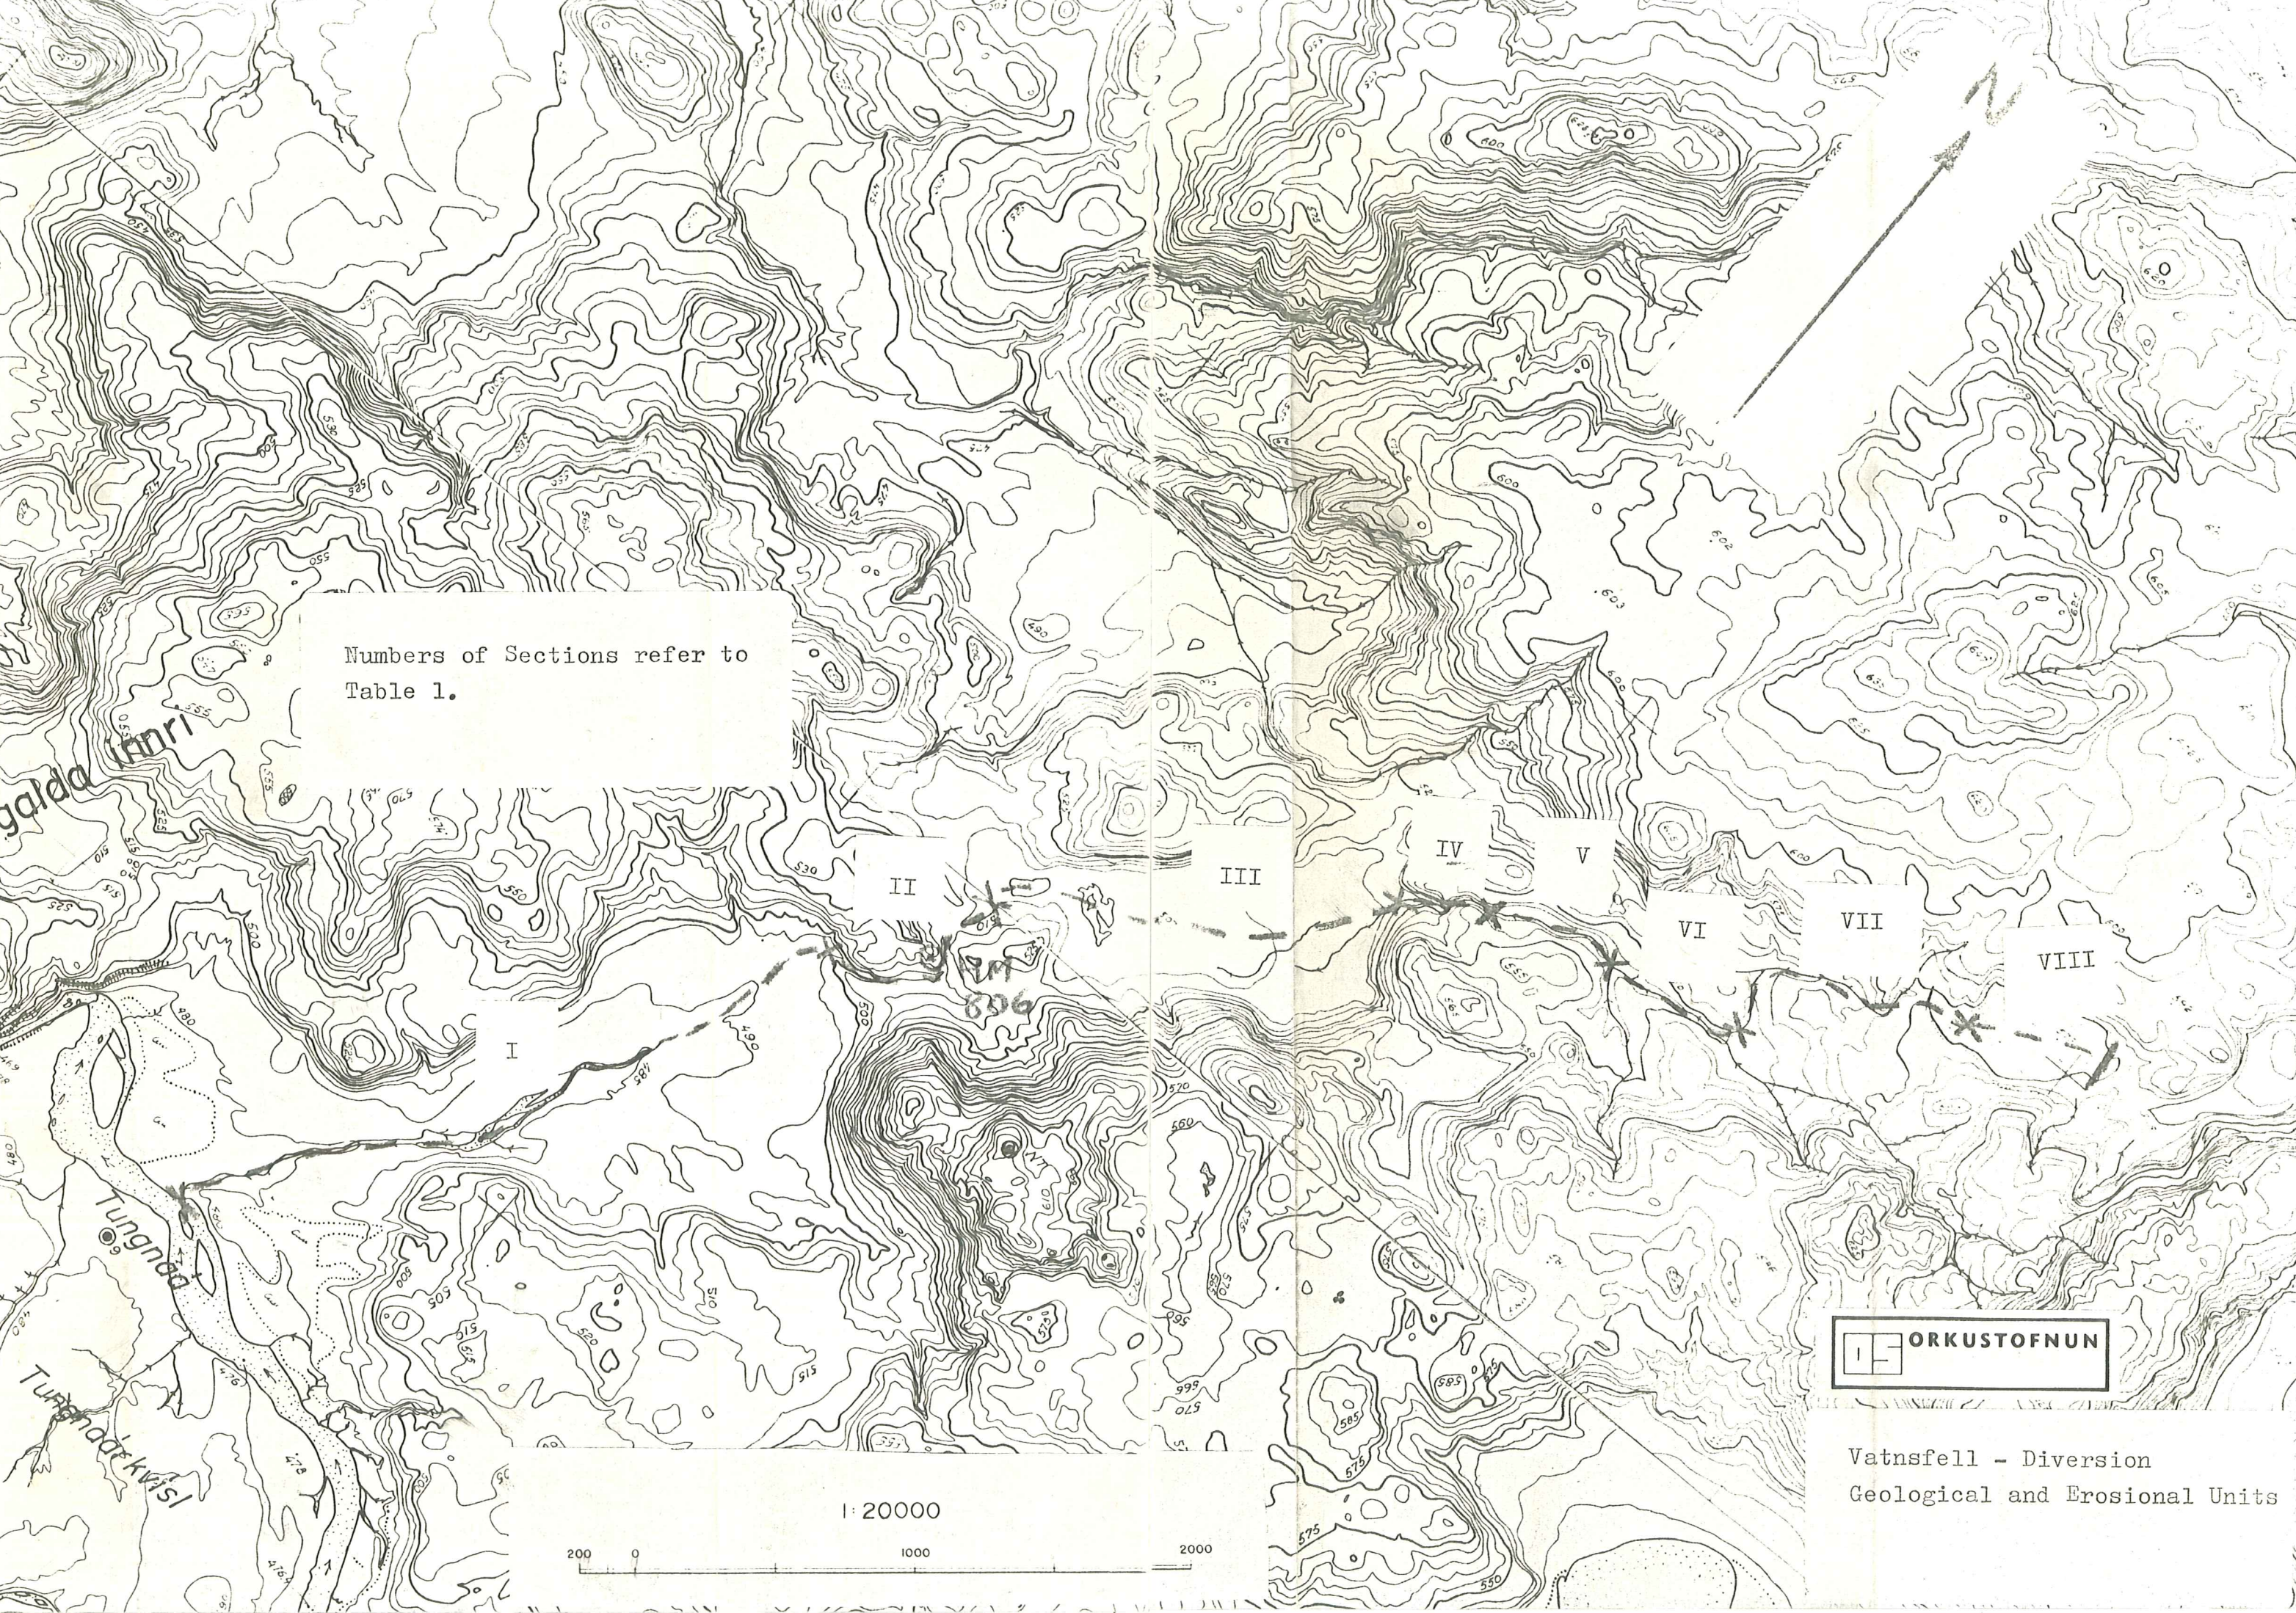
Vatnsfell - Diversion
Geological and Erosional Units

For convenience we divided the diversion according to geological and erosional features, as shown on fig. 1. These sections are as follows

Section I: The erosion in this section has only occurred in superficial deposits, consisting of Lake Krókslón sediments, mostly diatomic clay, which is covered by eolian sand and colluvial deposits. In the beginning the erosion cut down a new channel forming a new gradient fitting to the great volume of water, but later the lateral erosion became dominating.

Section III: This section consists of a sand-filled depression. The erosion there is managed by the rock dam of Section II and the discharge of the diversion.

Section IV: The channel of this section is a gorge with some waterfalls in cube jointed basalt. The lowest part of the gorge is an older, tuffaceous formation with a tillite cover, which is more easily eroded than the upper one. The deepest part of the gorge, a plunge pool, is directed by a E-W going fracture. ^{zone} The greatest part of the gorge is cut into the cube jointed basalt formation which is the strongest and most resistant bedrock in that area. The fracture in the cube jointed basalt reaches only the lowest part of the gorge where the underlying tuff dips steeply to the North. This makes the basalt a still stronger threshold against further erosion, even though it can not be said to be very resistant.

Section V: The section consists of a sand filled depression. The erosion there behaves in similar way as in Section III and is managed by the bedrock of Section IV.

Section VI: This section is the nearest one to the end of the previously dug canal. The erosion shows that this section was a sand filled stream channel underlain by tuffaceous breccia which was near the surface at the upper end but dipping downstreams. In the beginning the erosion formed a wide channel where the sand washed away. Later on the erosion cut rather deep and narrow channels into the breccia directed by tectonic fractures. There are three main tectonic trends in that area: ENE, NE and N. At the upper end of this section these channels now reach about 10 m depth, causing great erosion in the dug canal.

Section VII: The section is the lowest part of the cut, that is where erosion already has occurred. The section is built up of breccia and pillow lava. In the lowest

part the original cut is quite eroded and transformed into a gorge following the main tectonic trends. But further up in the section there has mainly occurred bottom erosion with some slides from the walls which only in some cases can be attributed to tectonic fractures. The original slope of this section was 2 o/cc, but has increased to 12 o/cc (see Table 1).

Section VIII: The cut there is built up of pillow lava, breccia and some sandy deposits. Hardly any erosional features can be observed there but some tectonic fissures are to be seen. The cut still keeps its original 2 o/cc slope. This slope causes no apparent erosion.

The present paper gives only a brief idea about what is going on in the erosions matter of Vatnsfells Diversion. For further studies it would be necessary to map the present conditions there at least with 5 m contour intervals for more exact calculations and for geological mapping of the erodible material and the visual tectonic there.

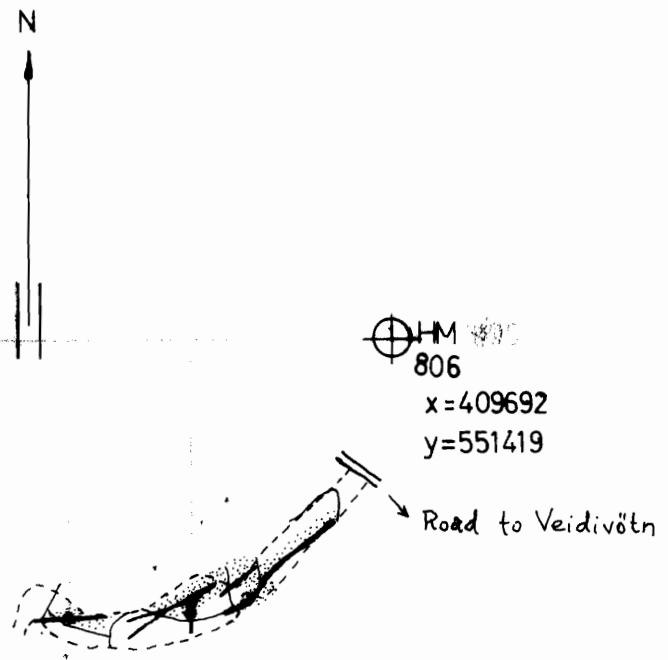
Section II: This section crosses subglacially formed volcanic ridge, consisting of some pillow lavas, breccia and tuffs, as shown on fig. 2. The ridge slopes are covered by tillite (often named pseudo-Môberg). In the uppermost part of the section the tillite is far thickest where the ice pressure has folded the bottom moraine together with the uppermost part of the brecciated tuff. In the middle of the section there also is some tillite. Although the tillite is jointed to some extent, it is far more resistant against the water erosion than the underlying volcanic rocks. Two types of fractures occur in these rocks. The first type is the settling one, formed during or shortly after the eruption. Usually, the fractures have been filled with fine grained material, which after consolidation is more resistant to erosion than the surrounding rocks (breccia and tuffs). The second type of fractures belongs to the regional tectonic of that area. The clearest ones are shown on fig. 2, giving all the main tectonic directions of the area as a whole. Most usually these fractures are filled with rather fine grained material, in some cases narrow fractures are still open. In one case we found a filled fracture had opened again after consolidation of the filling. In this new fracture there was some unconsolidated material, mainly in the sand-gravel fraction, consisting of palagonized and unaltered volcanic glass.

The tuffs and the breccia seem to be eroded rather easily. Fractures of the first type have very little effect on the erosion, but fractures of the second type seem to some extent trend the erosion to follow the fractured zones. The effect of the fracture zones appears also in forming narrower and deeper gulleys than elsewhere.
