Presented at "Short Course on Geothermal Drilling, Resource Development and Power Plants", organized by UNU-GTP and LaGeo, in Santa Tecla, El Salvador, January 16-22, 2011.

GEOLOGICAL HAZARDS AND GEOTECHNICAL ASPECTS IN GEOTHERMAL AREAS, THE EL SALVADOR EXPERIENCE

Luz Barrios, Baltazar Hernández, Arturo Quezada, Carlos Pullinger

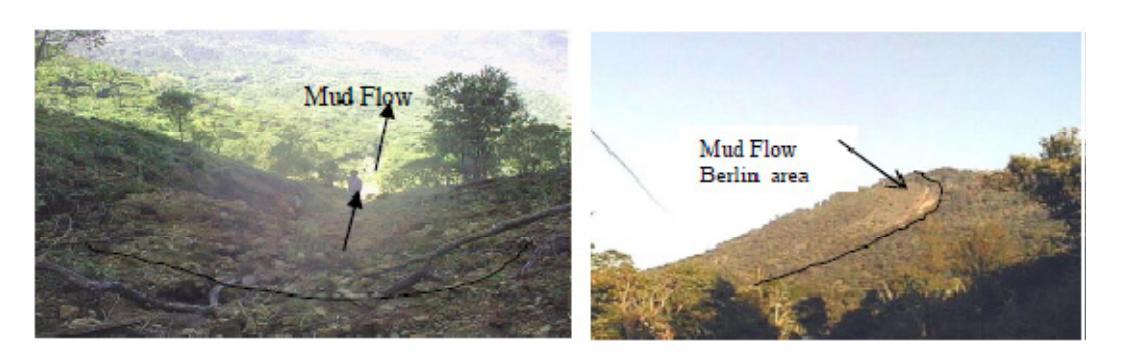
On October 1998, Hurricane Mitch caused a series of landslides, debris flows, and rock falls that affected the town of Berlin, closed down the main roads leading to the town and the geothermal power plant and caused some damages to geothermal installations. The majority of these were located in the steep slopes of the volcanoes, south of the geothermal power plant and closely associated to the presence of road cuts, hydrothermally altered and fumarolic areas. Photos of instability phenomena recorded during Hurricane Mitch are shown in Figure 3.

FIGURE 3: Mud flows in the Berlin Tecapa Volcano. a) along a drainage, and b) along the slope close to the Berlin town

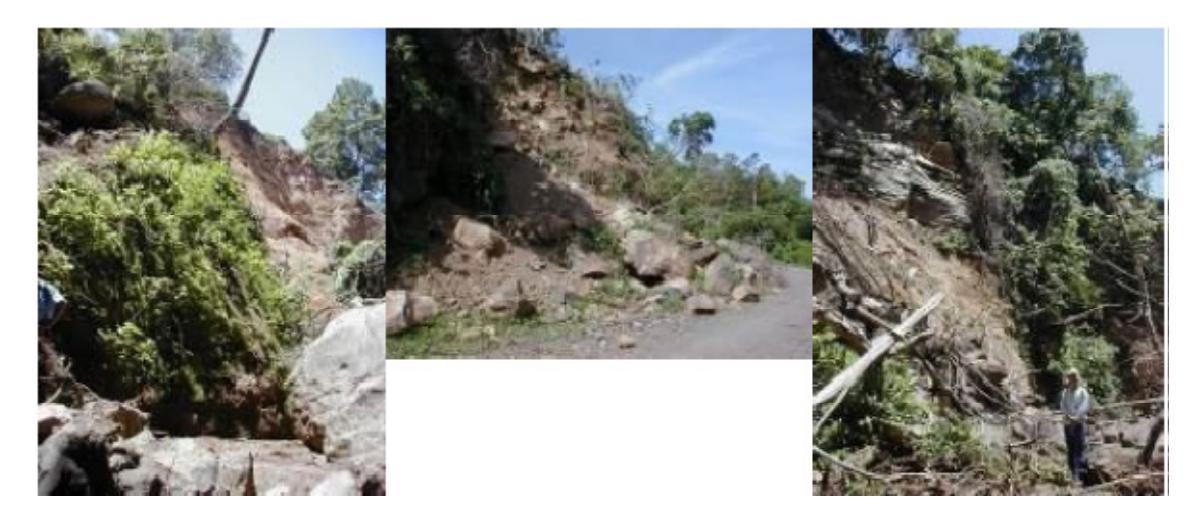
In addition to the heavy rainfall in the Berlin geothermal seismic activity has also caused landslides. The 2001 earthquakes that affected El Salvador during January 13th and February 13th caused at least twenty small rock falls and landslides, most of which were located along the main road to the city of Berlin and the geothermal power plant (Figure 4). Rock falls also fell on well pad TR-2, which is located next to an almost vertical 25 meter slope.

FIGURE 4: Several rock falls located a) West of TR4, Berlin Field, b) Road Mercedez Umaña-Berlin City, c) West of well TR11, occurred during the two earthquakes in January 13th and February 13th 2001.

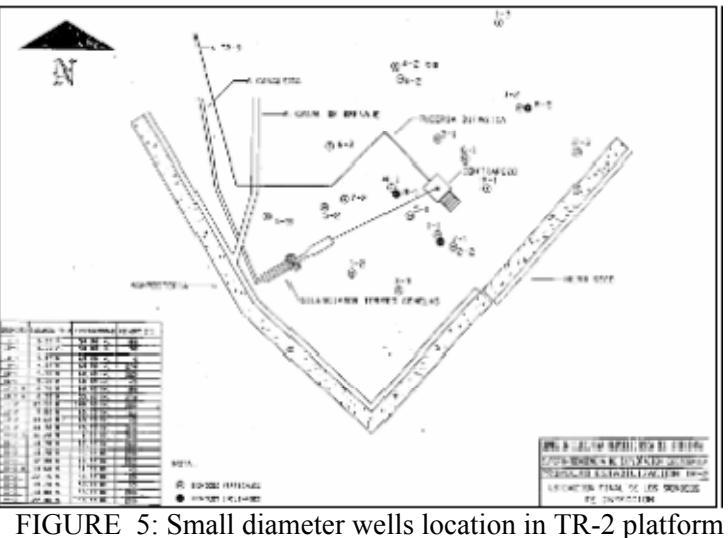
An example of such works is well TR-2 which was drilled from January to June 1978. At the end of 1992 and the beginning of 1993 twenty small diameter wells with 50-100 m depth were drilled in that platform in order to stabilize the surroundings of the cellar (Figure 5). Cement slurry was injected in the wells to seal the fractures where gases and steam flowed up to surface. At the end of the work 70 % of the hydrothermal manifestations decreased around the well. Similar works were performed in other pads (TR-7, TR-10, etc).

FIGURE 5: Small diameter wells location in TR-2 platform (CEL, 1993)

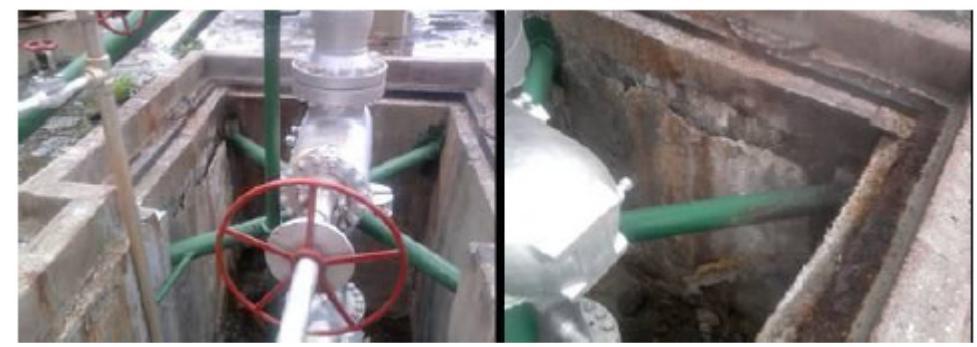
In the year 2010, the cellar of well TR2, evidenced degradation of the cement and steam started coming out from some small fractures located on the northern walls (Figure 6). Figure 7 shows temperature distribution measured at 50 cm depth. Figure 8, shows the evolution of the slope since the year 1992 to 2010. In the year 2010, the southern slope was repaired with concrete shots and steel

FIGURE 6: Damages on the cellar, well TR-2. Hydrothermal manifestations in the northern corner

mesh to retain any rock fall. Several landslides in the surrounding walls of the scarp, occurred throughout the years 1998, 2001, 2003, 2007 and 2010. Most of them were stabilized.

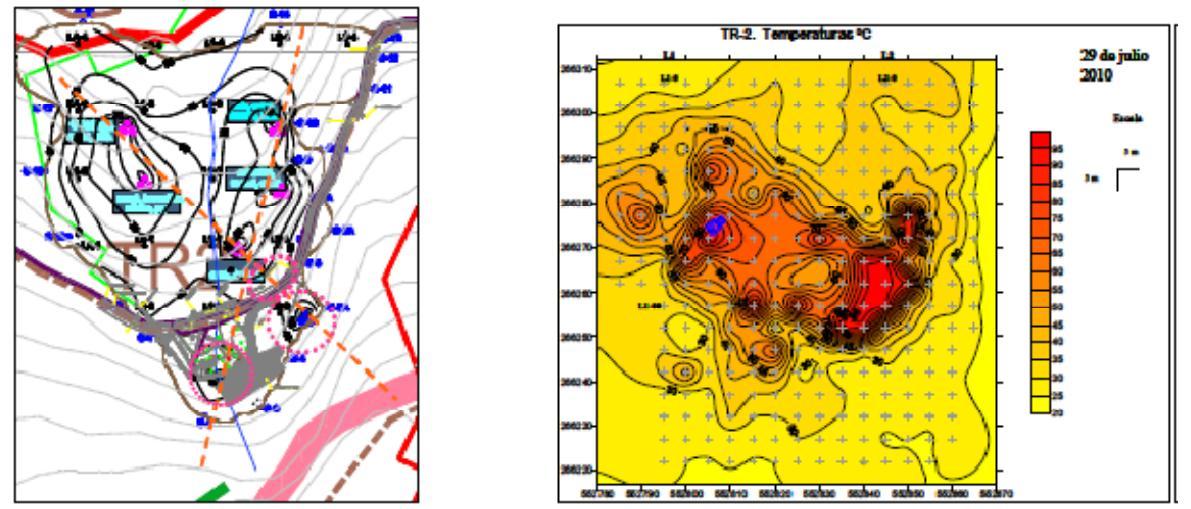
FIGURE 7: Temperatures (in °C) measured in July 2010; notice temperatures are higher than 90°C in the southeast slope and where the well is located. It follows a structural trend NW-SE and NE-SW

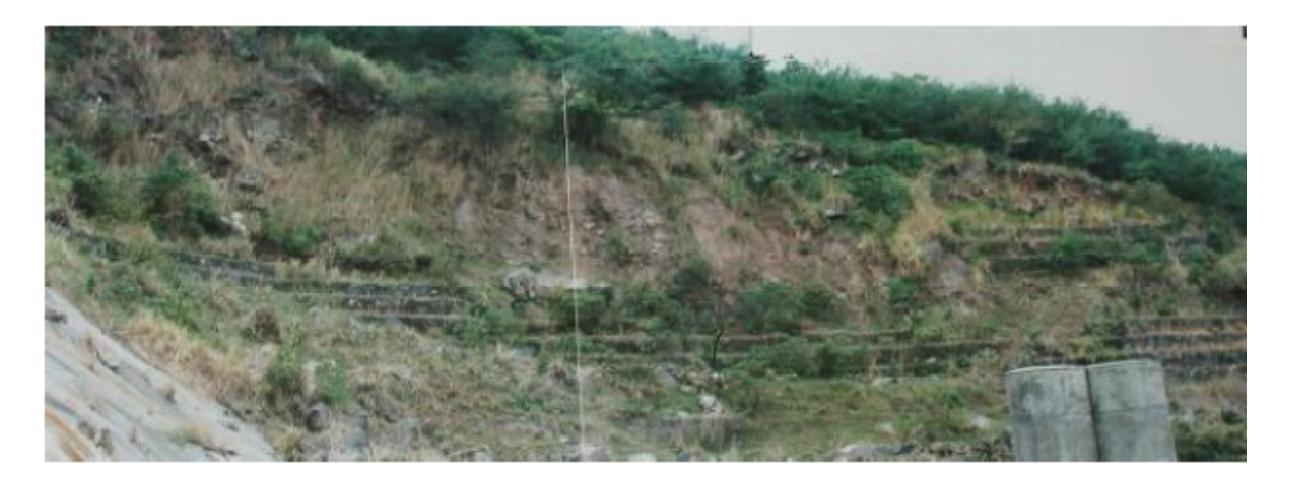
FIGURE 8: Western slope of platform TR2 in the year 1990-1991; several gabion walls were built

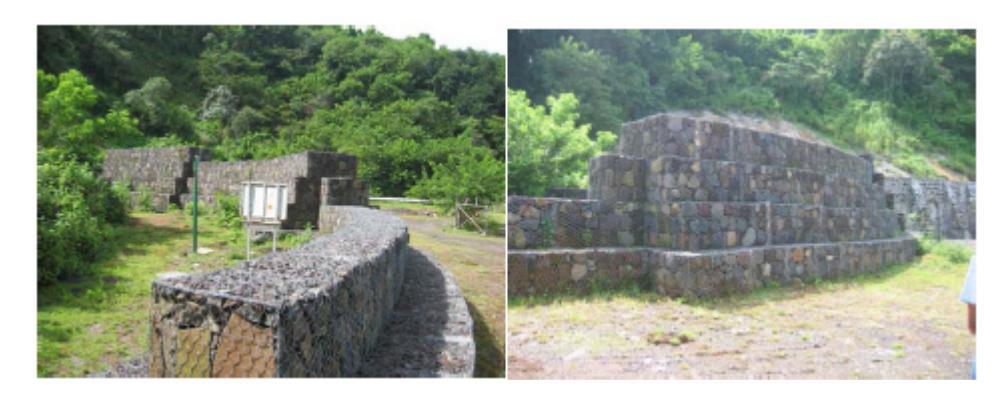
Figure 9 shows several gabion walls built from year 1990-1991 to stabilize the western slope of the TR2 pad. By the year 2010, this wall is completely covered with vegetation and several landslides have occurred in the years 1998, 2001, 2003, 2007 and 2010. Mitigation works started in the year 2003 and Figure No. shows the gabion walls built to retain any rock

FIGURE 9: Gabion wall at TR2 as seen from the east side. The dam is built in sections, 2, 4, and 5 m high, as seen on the picture. b) The gabion wall seen from the north side

fall, mud flow and landslides. In 2011 the civil works will continue to stabilize the recent landslides occurred at the end of 2010.

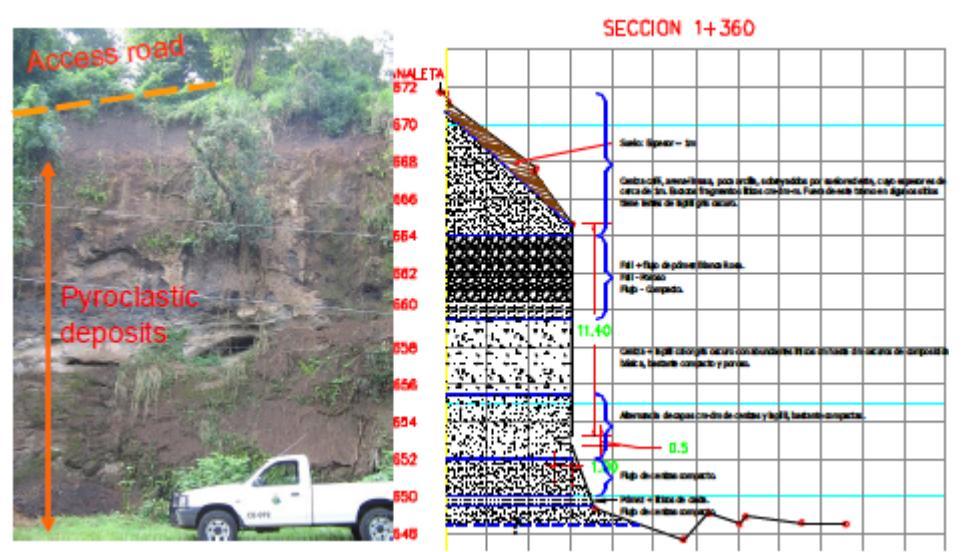
FIGURE 10: The access road to TR-19 pad, located on top of the pyroclastic deposits

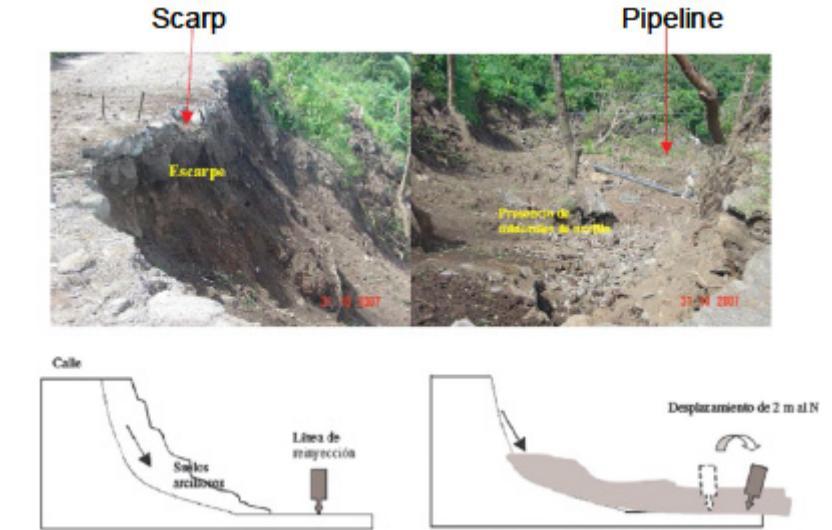
In the geothermal fields from El Salvador, the main problems related to the foundations of the pipe lines bases are related to the stability of slopes and the soil erosion. In October 2007, a small landslide affected the reinjection line to the TR-19 wells, near to La Flecha area, where a debris flow material slide over underlying deposit formed by clays produced by hydrothermal alteration. The bases of the pipeline were displaced around two meters (Figure 11).

FIGURE 11: Photos and scheme of the landslide that affected the reinjection pipeline near to the La Flecha hydrothermal alteration area, Berlín geothermal field in October 2007 (From Henríquez and García, 2007)

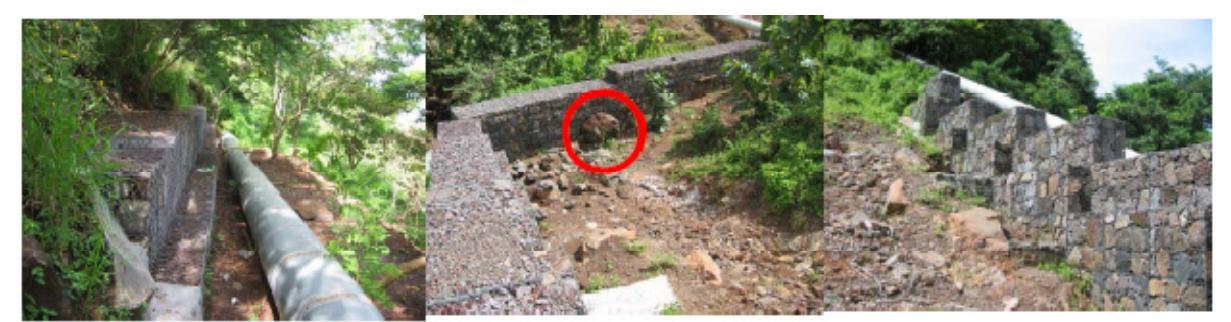
FIGURE 12: a) The gabion wall is adjusted and not leaning against the pipeline. b) The gabion wall is build to secure the pipeline (following the outer side of the wall) against slides. A rock fall has already hit the wall (red circle), without making any signs of destruction. c) The gabion wall along the pipeline down slope seems sufficient to prevent new damages from slides.

The fundaments of the pipeline were partly damaged in a previous slide

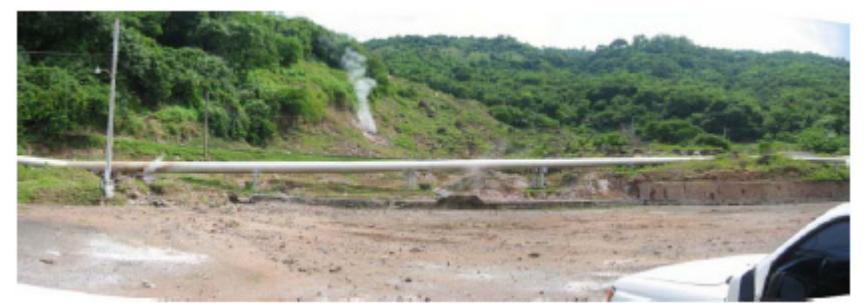
The steam gathering system near the power plant which carries all the steam from production wells TR2, TR9, TR4's, TR5's, TR17's and TR18's, cross the fumarolic area called El Tronador which is associated to a landslide scarp. A gabion wall was built south of the pipelines to protect them from any rock fall and landslide (Figure 12).

FIGURE 13: El Tronador Fumarolic area with steam gathering system near the Berlin power plant. A long gabion wall was built on the southern flank of the pipeline

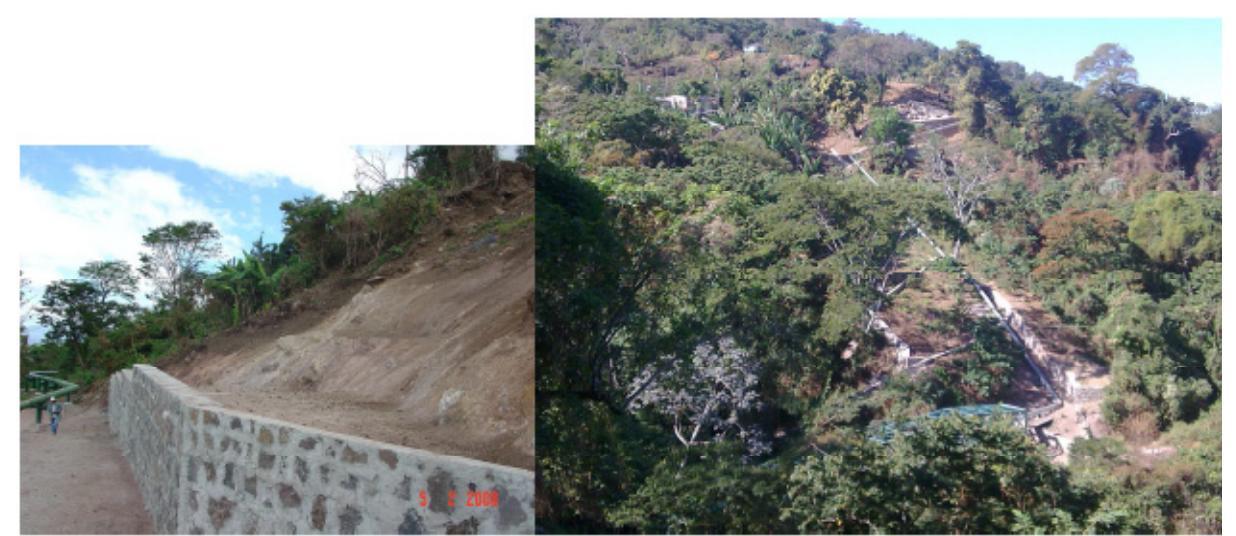
FIGURE 14: a) Mitigation works on the northern slope of the gathering system TR17s/TR18's to injection well TR19's after a landslide occurred in the year 2007. b) Gathering system along the slope close to TR19 injection well
