Grundartangi, Hvalfjörður
Water Supply Investigation

By
Freyr Þórarinsson and
Laufey Hannesdóttir

Prepared for
Icelandic Alloys, Ltd.
Ferrosilican Plant

August 1975

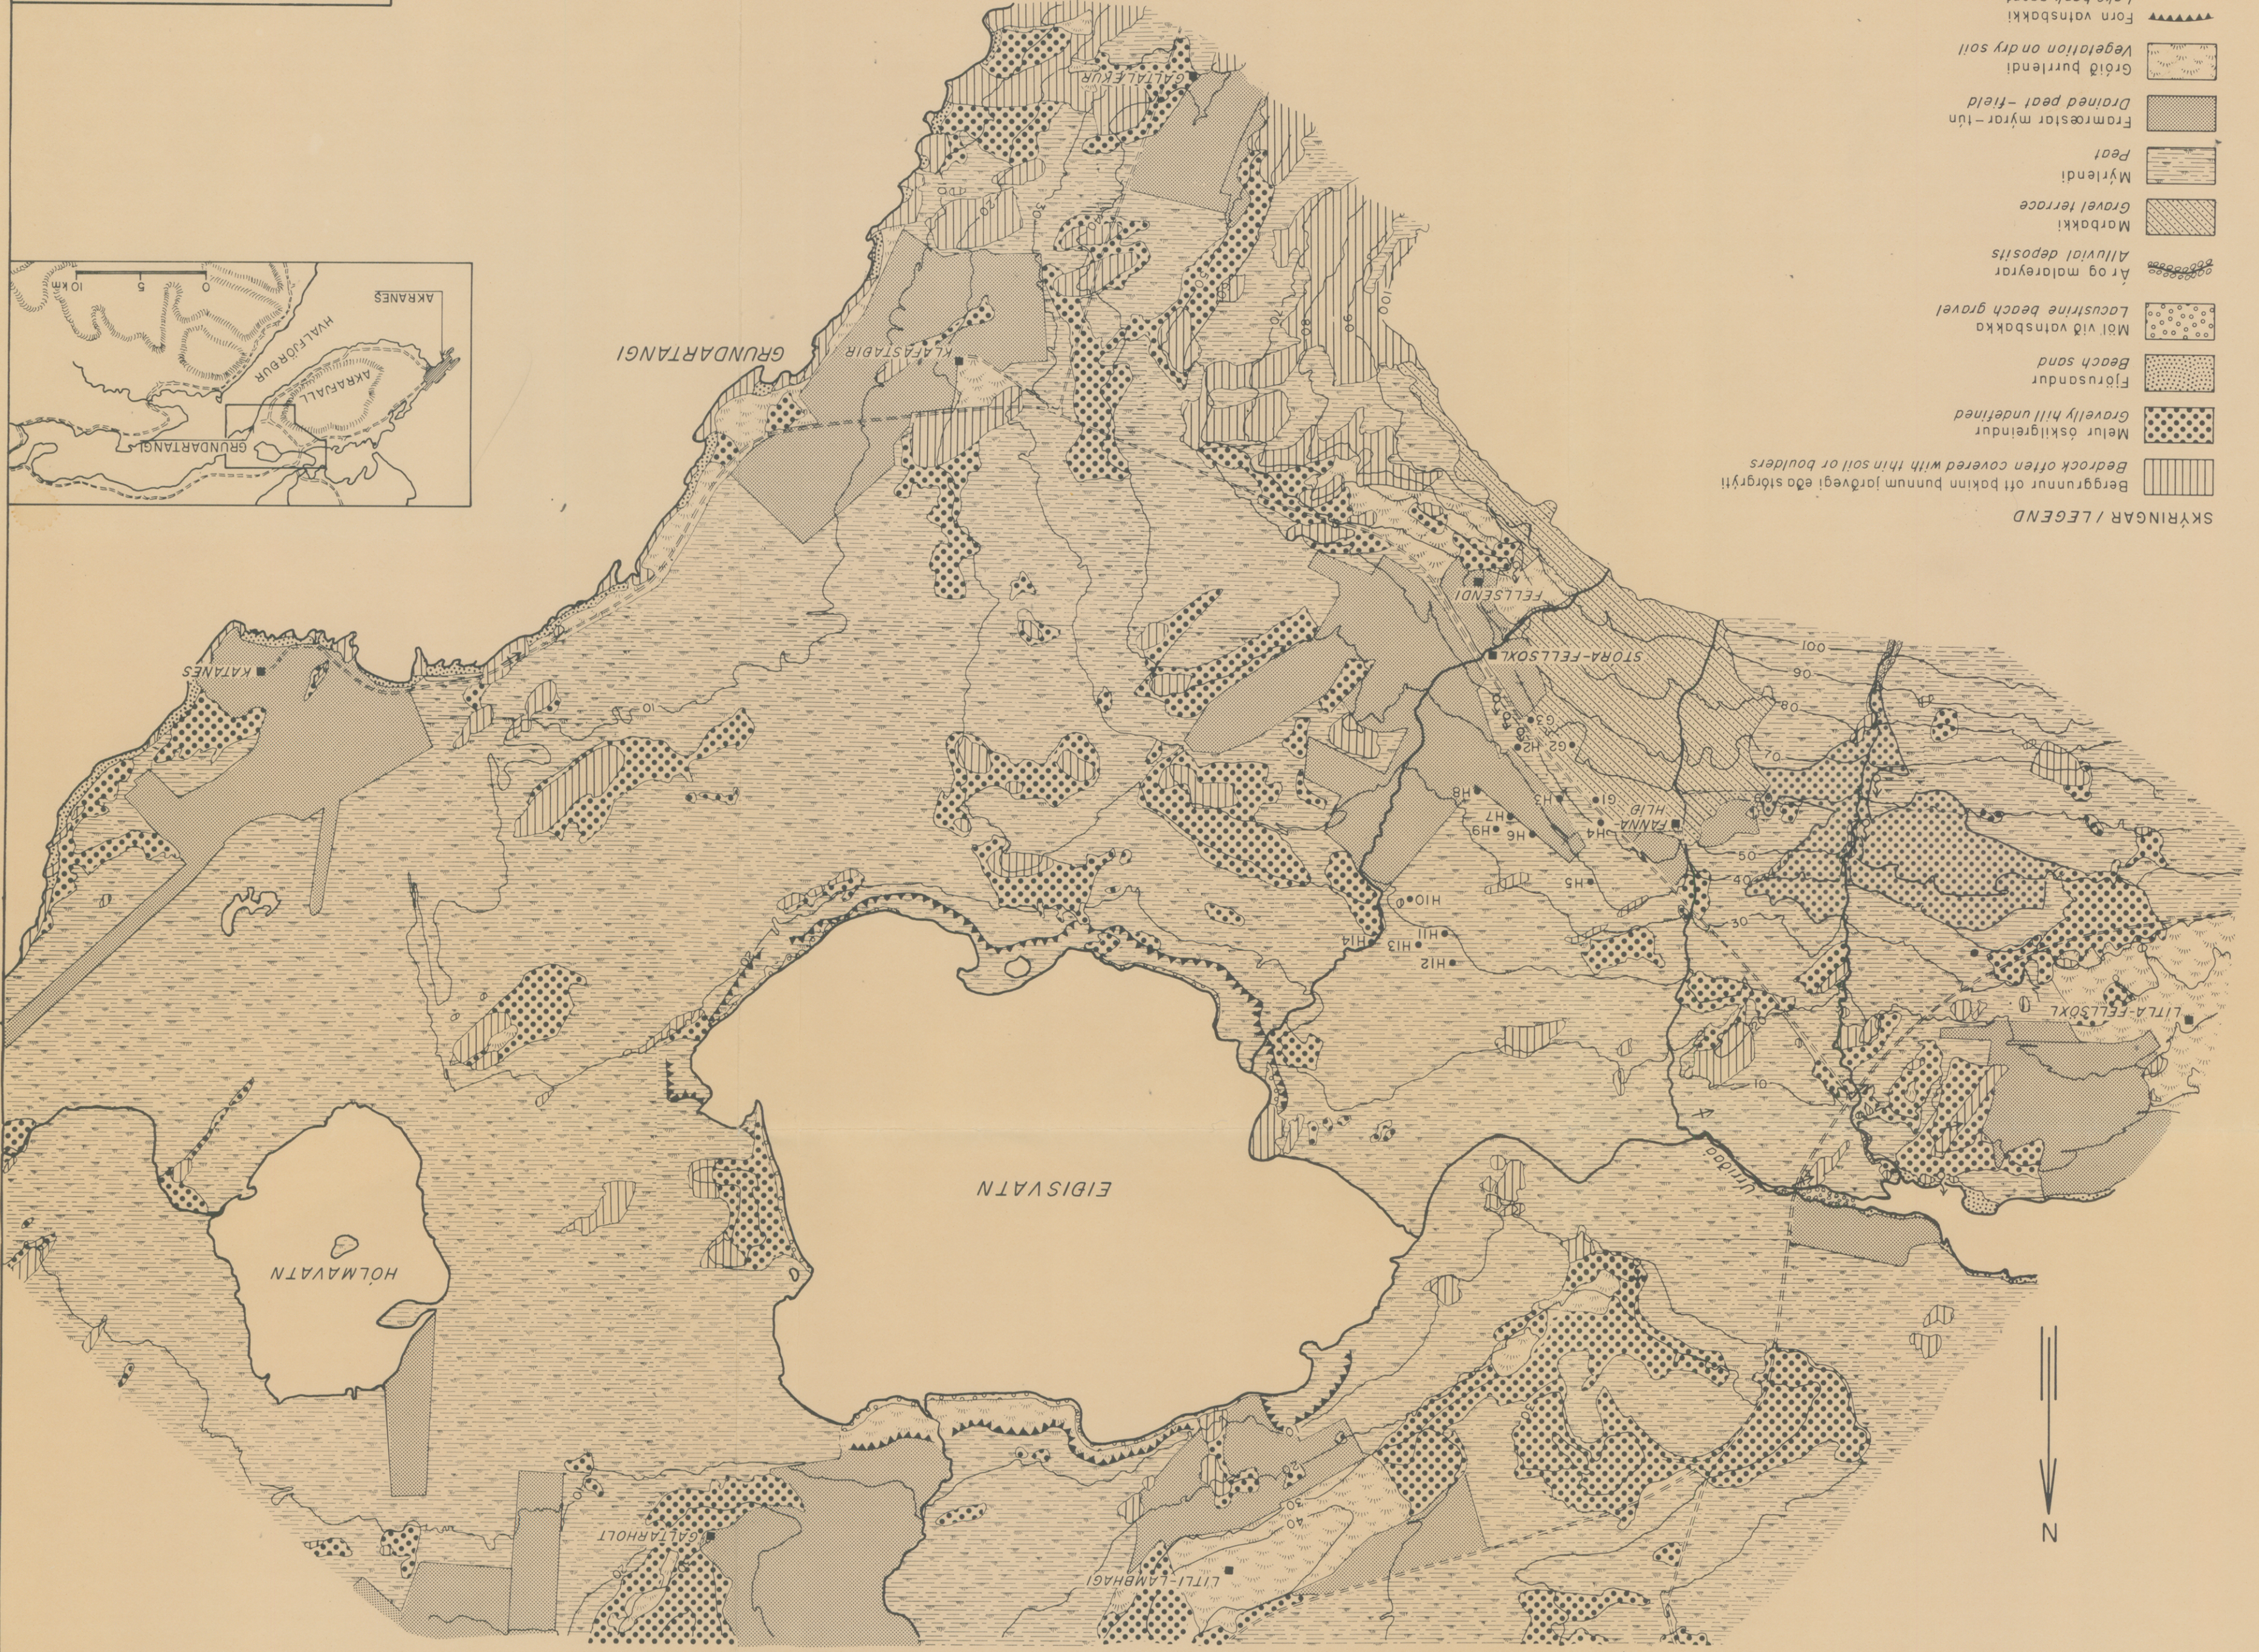
Map 2.1 shows the surficial geology of the study area. Most of the area is covered with peat but bedrock or gravelly hills crop out in some places.

ORKUSTOFNUN Jarðkönnunardeild
 PREPARED FOR ICELANDIC ALLOYS, LTD.
 FERROSILICON PLANT
 GRUNDARTANGI
 Jarðgrunnsskipti - Surficial Geology
 Water supply investigation
 26.875 LH/IS B-90
 Tm. 74
 Fm. 13295

Pits were dug by a tractor with a back-hoe up to 4 m deep in the study area to find out the physical properties of the layer defined by the seismic study under the peat and has sound velocity 2-3 km/sec. Also few pits were dug above the road in the gravel and these were pumped to find out how permeable the gravel is. The pits are marked on the surface geology map.

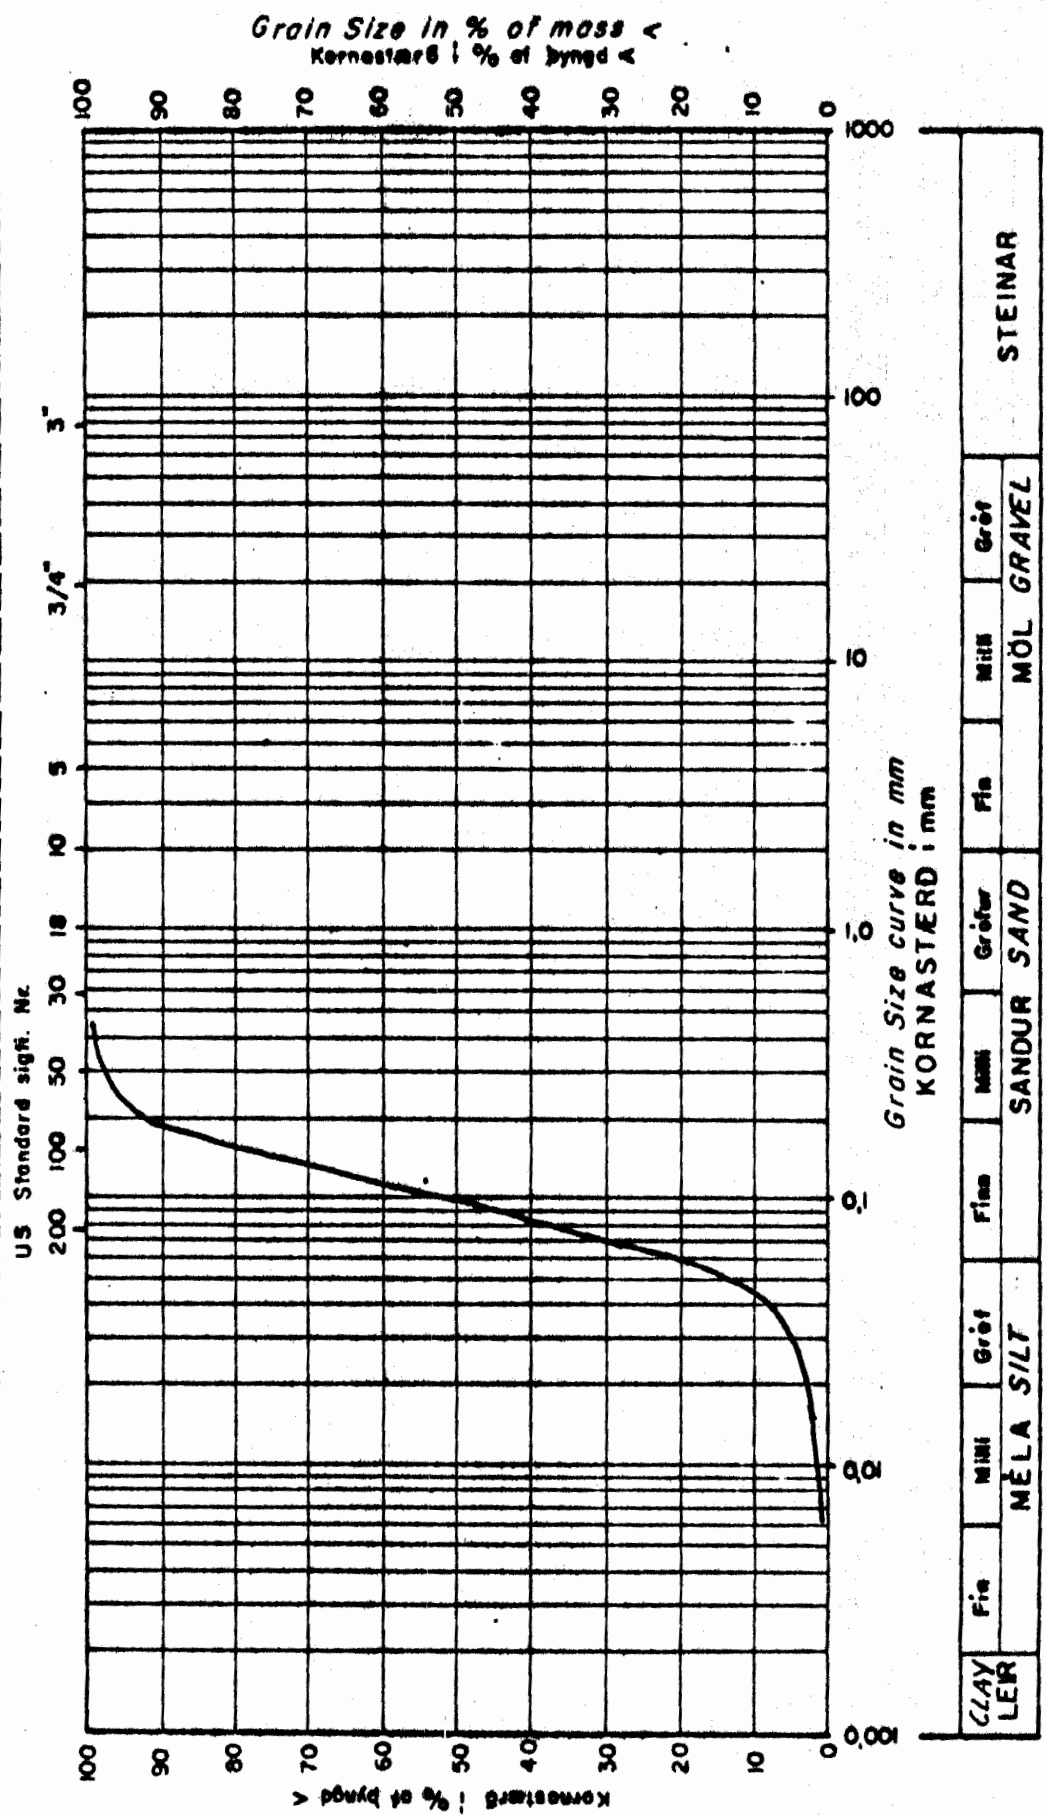
Fig. 5.8.

EIÐISVATN
BOTTOM SEDIMENTS - GRAIN SIZE CURVE
SAMPLE: M4-M5 V.

Figures 5.3 to 5.8 show the grain size curves in appendix.
