HESTVATN HYDRO-ELECTRIC PROJECT

HYDROLOGICAL REPORT

SIGURJÓN RIST

Reykjavík, July 1961

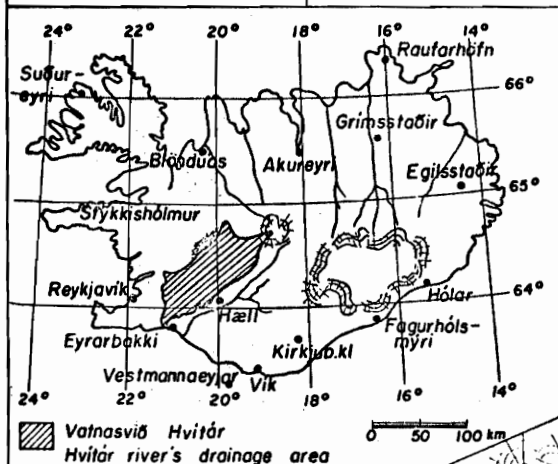
Mynd
Fig. 2-1

Vatnasvið Hvitár
Drainage Area of Hvítá River, km²

Fig. 2-1 shows the drainage area. The inset shows its geographical position within Iceland. Its size above the site of the proposed diversion dam at Árhraun is 4360 km². Its elevation ranges between 48 m at the damsite and 1765 on the Hofsjökull ice cap. The hypsometric curve in Fig. 2-2 shows for each elevation the percentage of the total area lying above that elevation.

No water gauge has been installed at the damsite, but the stream flow there has been computed from data furnished by water gauges Nos 2 and 64 (see Fig. 2-1), where records are available for 20 and 10 years, respectively. Therefore, stream-flow data are available for 10 years (1950/60) at the damsite. The mean discharge (MQ) for this period is 270 kl/s, corresponding to a mean annual yield ($M\sum aQ$) of 8492 Gl and a mean specific discharge of 62 l/s pr. km² of drainage area.

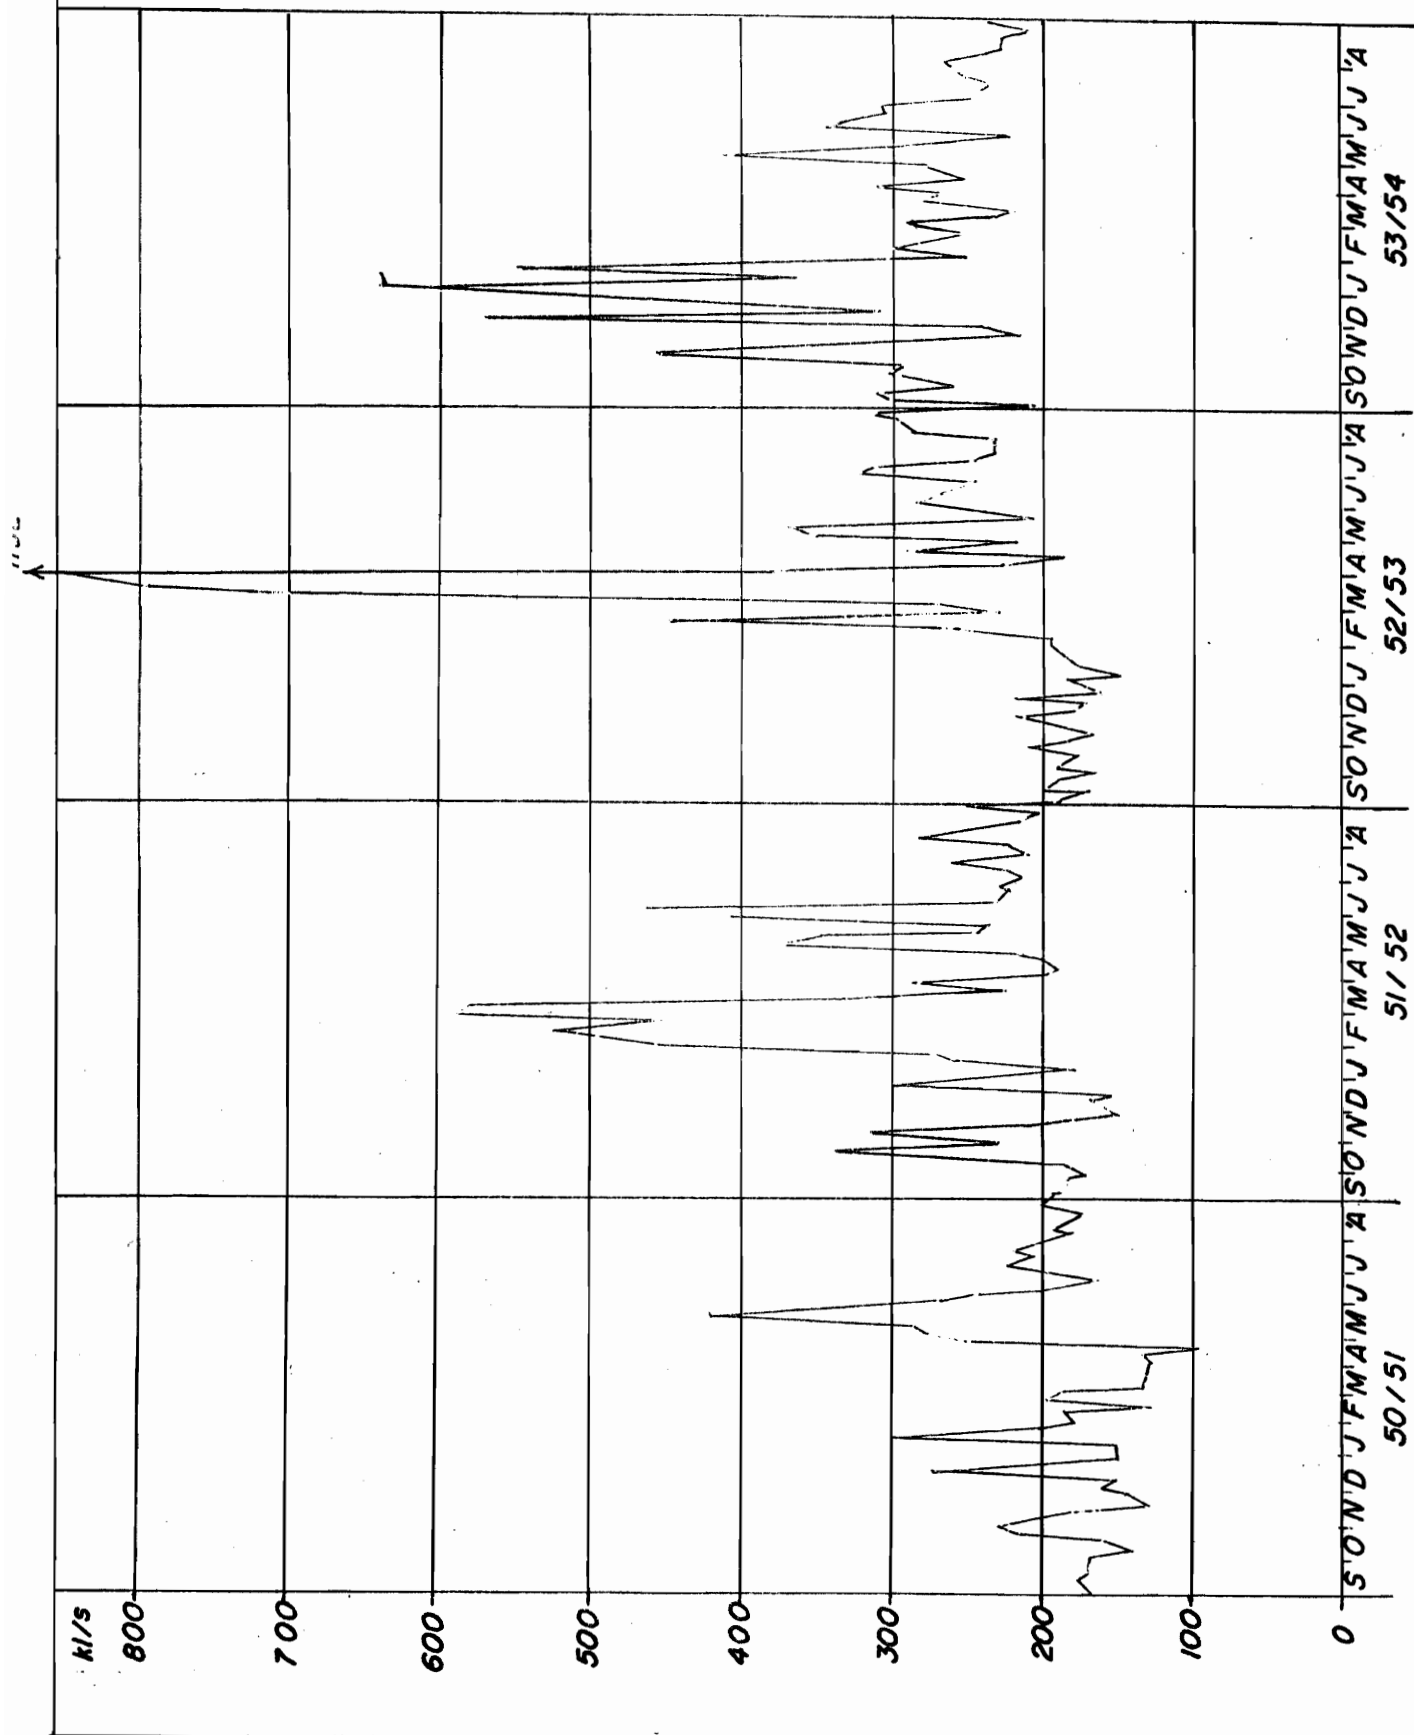
Weekly Averages of Discharge for the Water Years 1950/54

The tables in Figs 2-4 and 2-5 show monthly means of discharge (kl/s) and monthly yields (Gl) for the whole period of records (1950/60). Figs 2-6 and 2-7 show weekly averages of discharge for the water years 1950/58, and Fig. 2-8 shows a flow duration curve and flow utilization curve for the same period (50/58). The latter curve shows for each discharge the area below the flow duration curve up to that discharge, expressed as a percentage of the total area below the curve. Fig. 2-9 shows flow regulation curves for each of the water years 50/57 to 57/58, and, finally, fig. 2-10 shows cumulative storage curves, based on the regulation curves. These curves show the amount of storage, expressed as a percentage of mean annual yield ($M\sum aQ$, vertical scale) required to ensure in a given percentage of years (horizontal scale) a uniform discharge equal to any given percentage of the mean discharge (curve parameter).

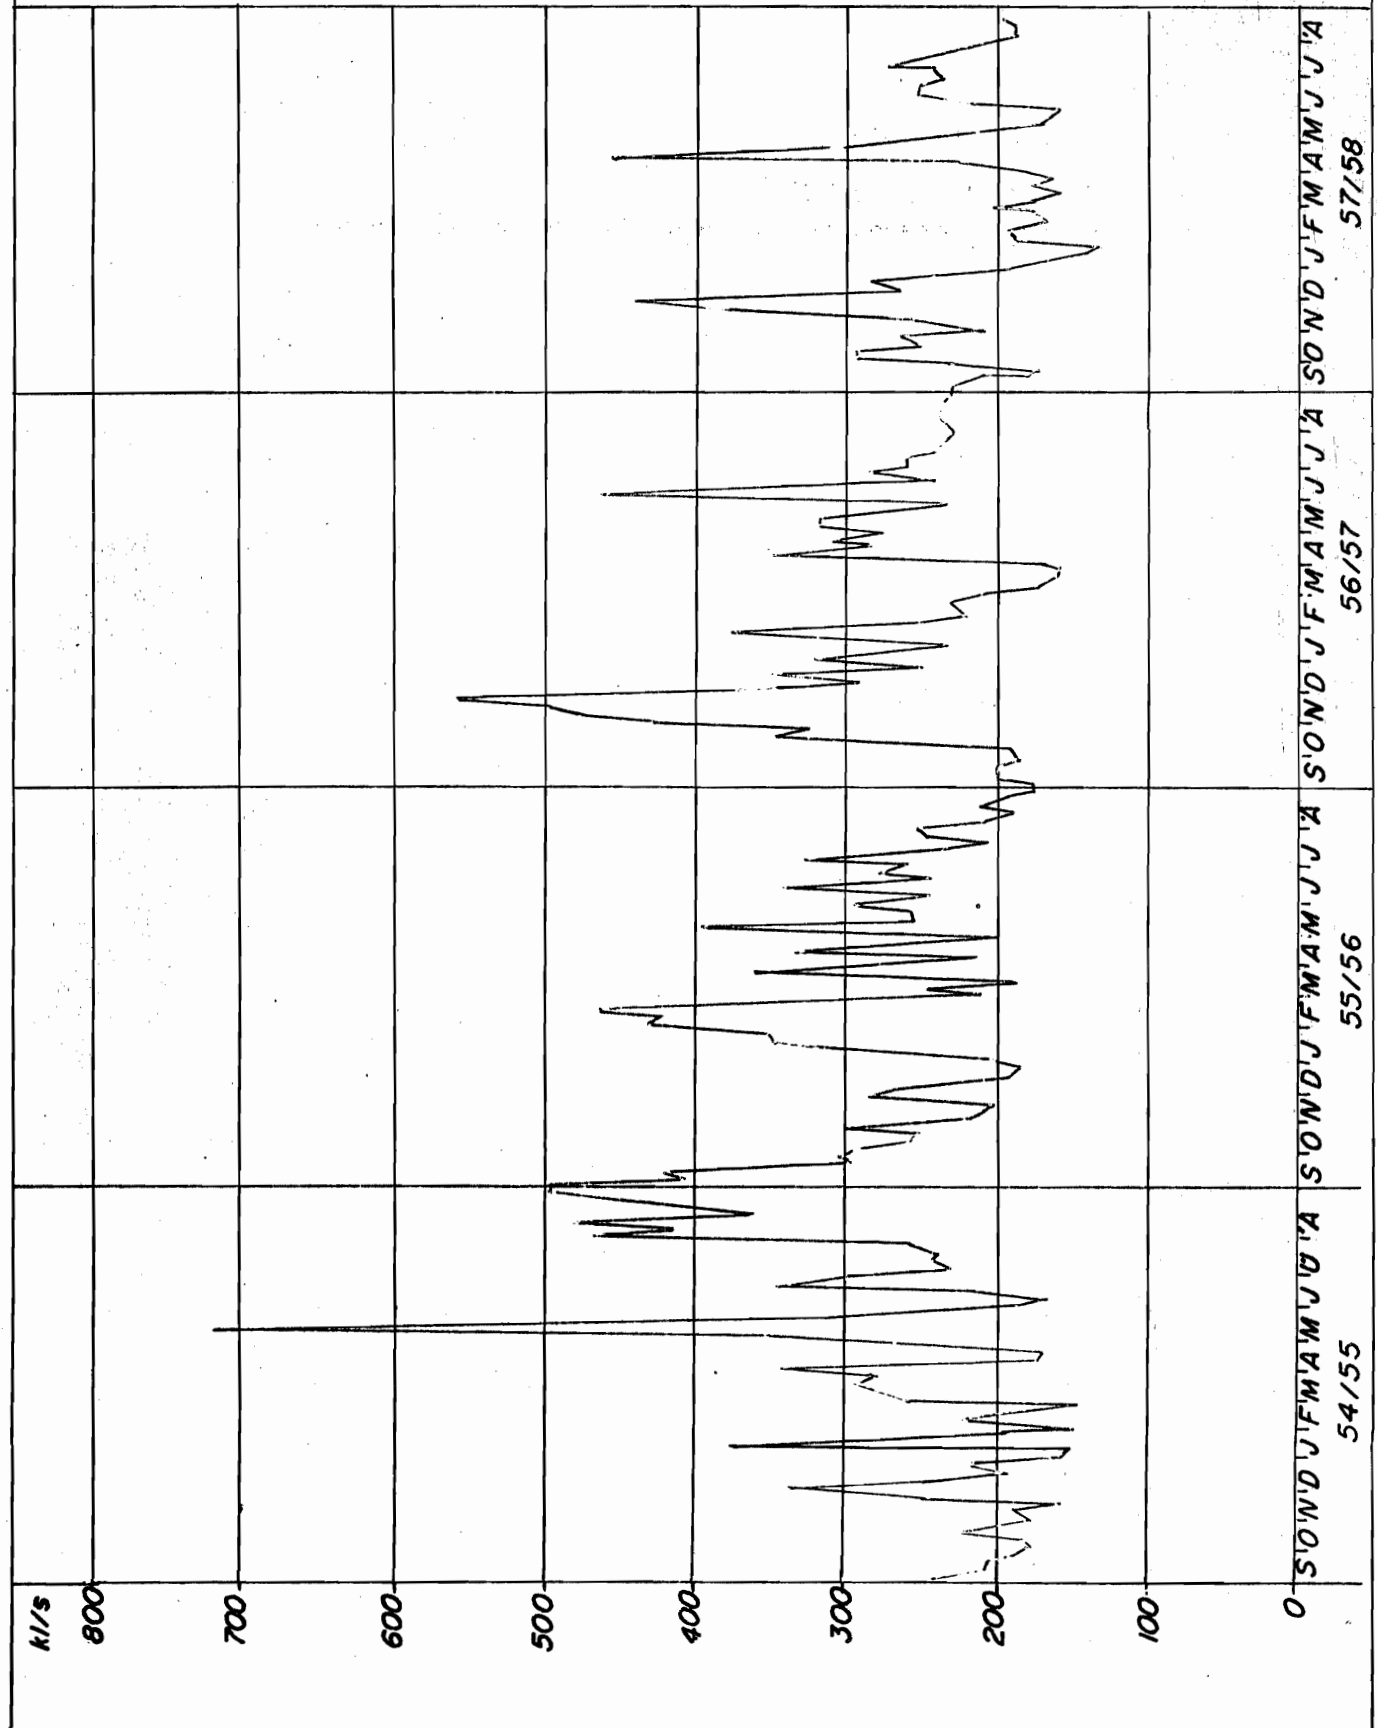
Weekly Averages of Discharge for the Water Years 1954/58

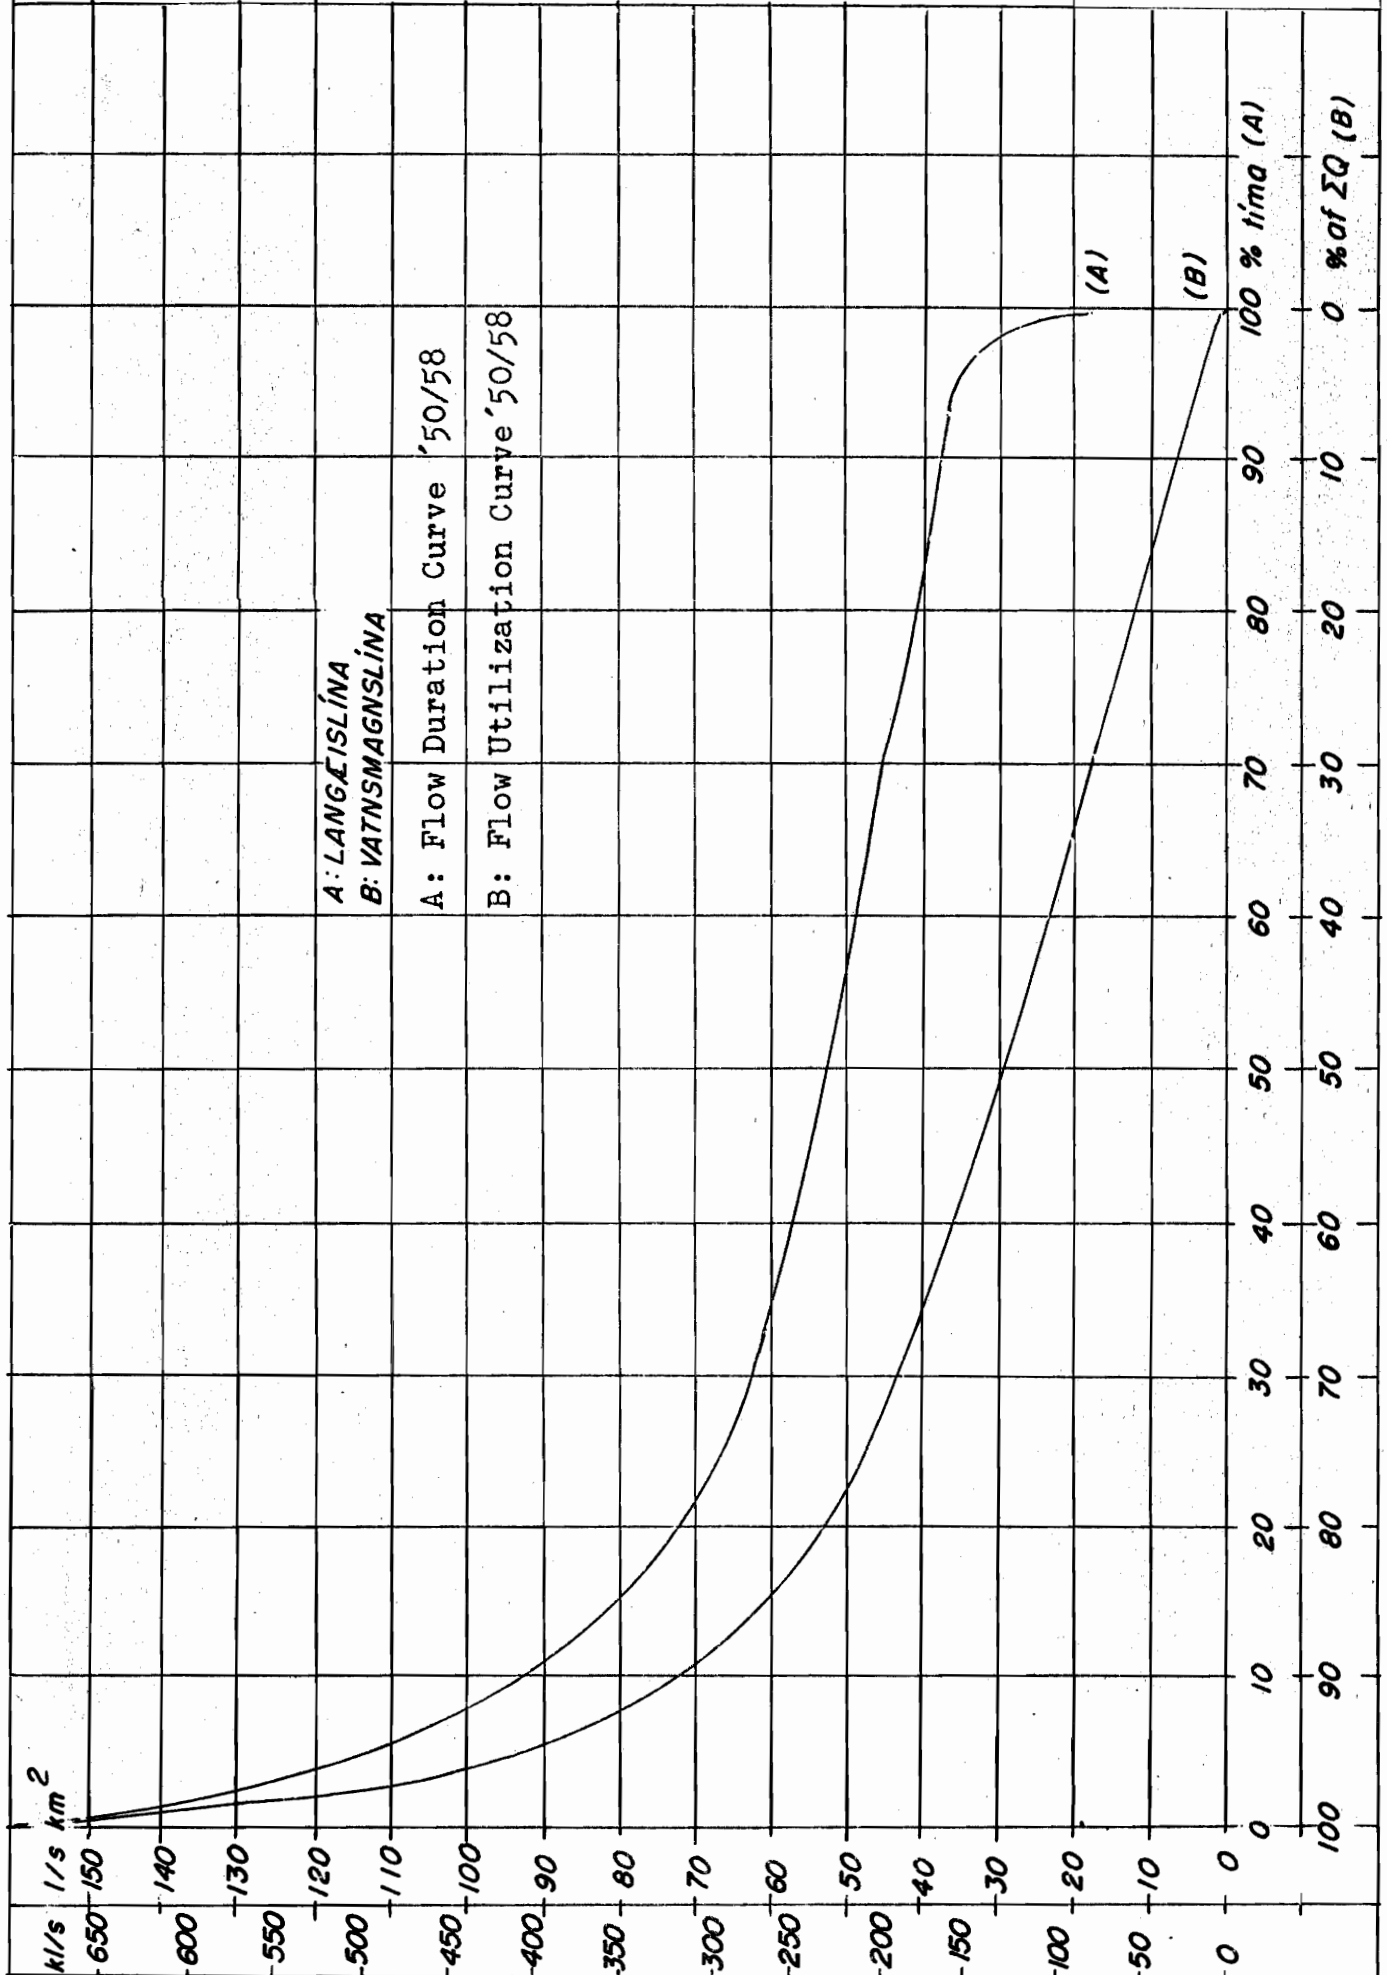
Mynd
Fig. 2-8

HVITÁ, HESTFJALL, ÁRHRAUN
LANGEISLÍNA, 8 ÁRA 1950/58

The Q_{95} is ab. 150 kl/s (Fig. 2-8), and the lowest recorded monthly mean is 155 kl/s (March '51, see Fig. 2-4).

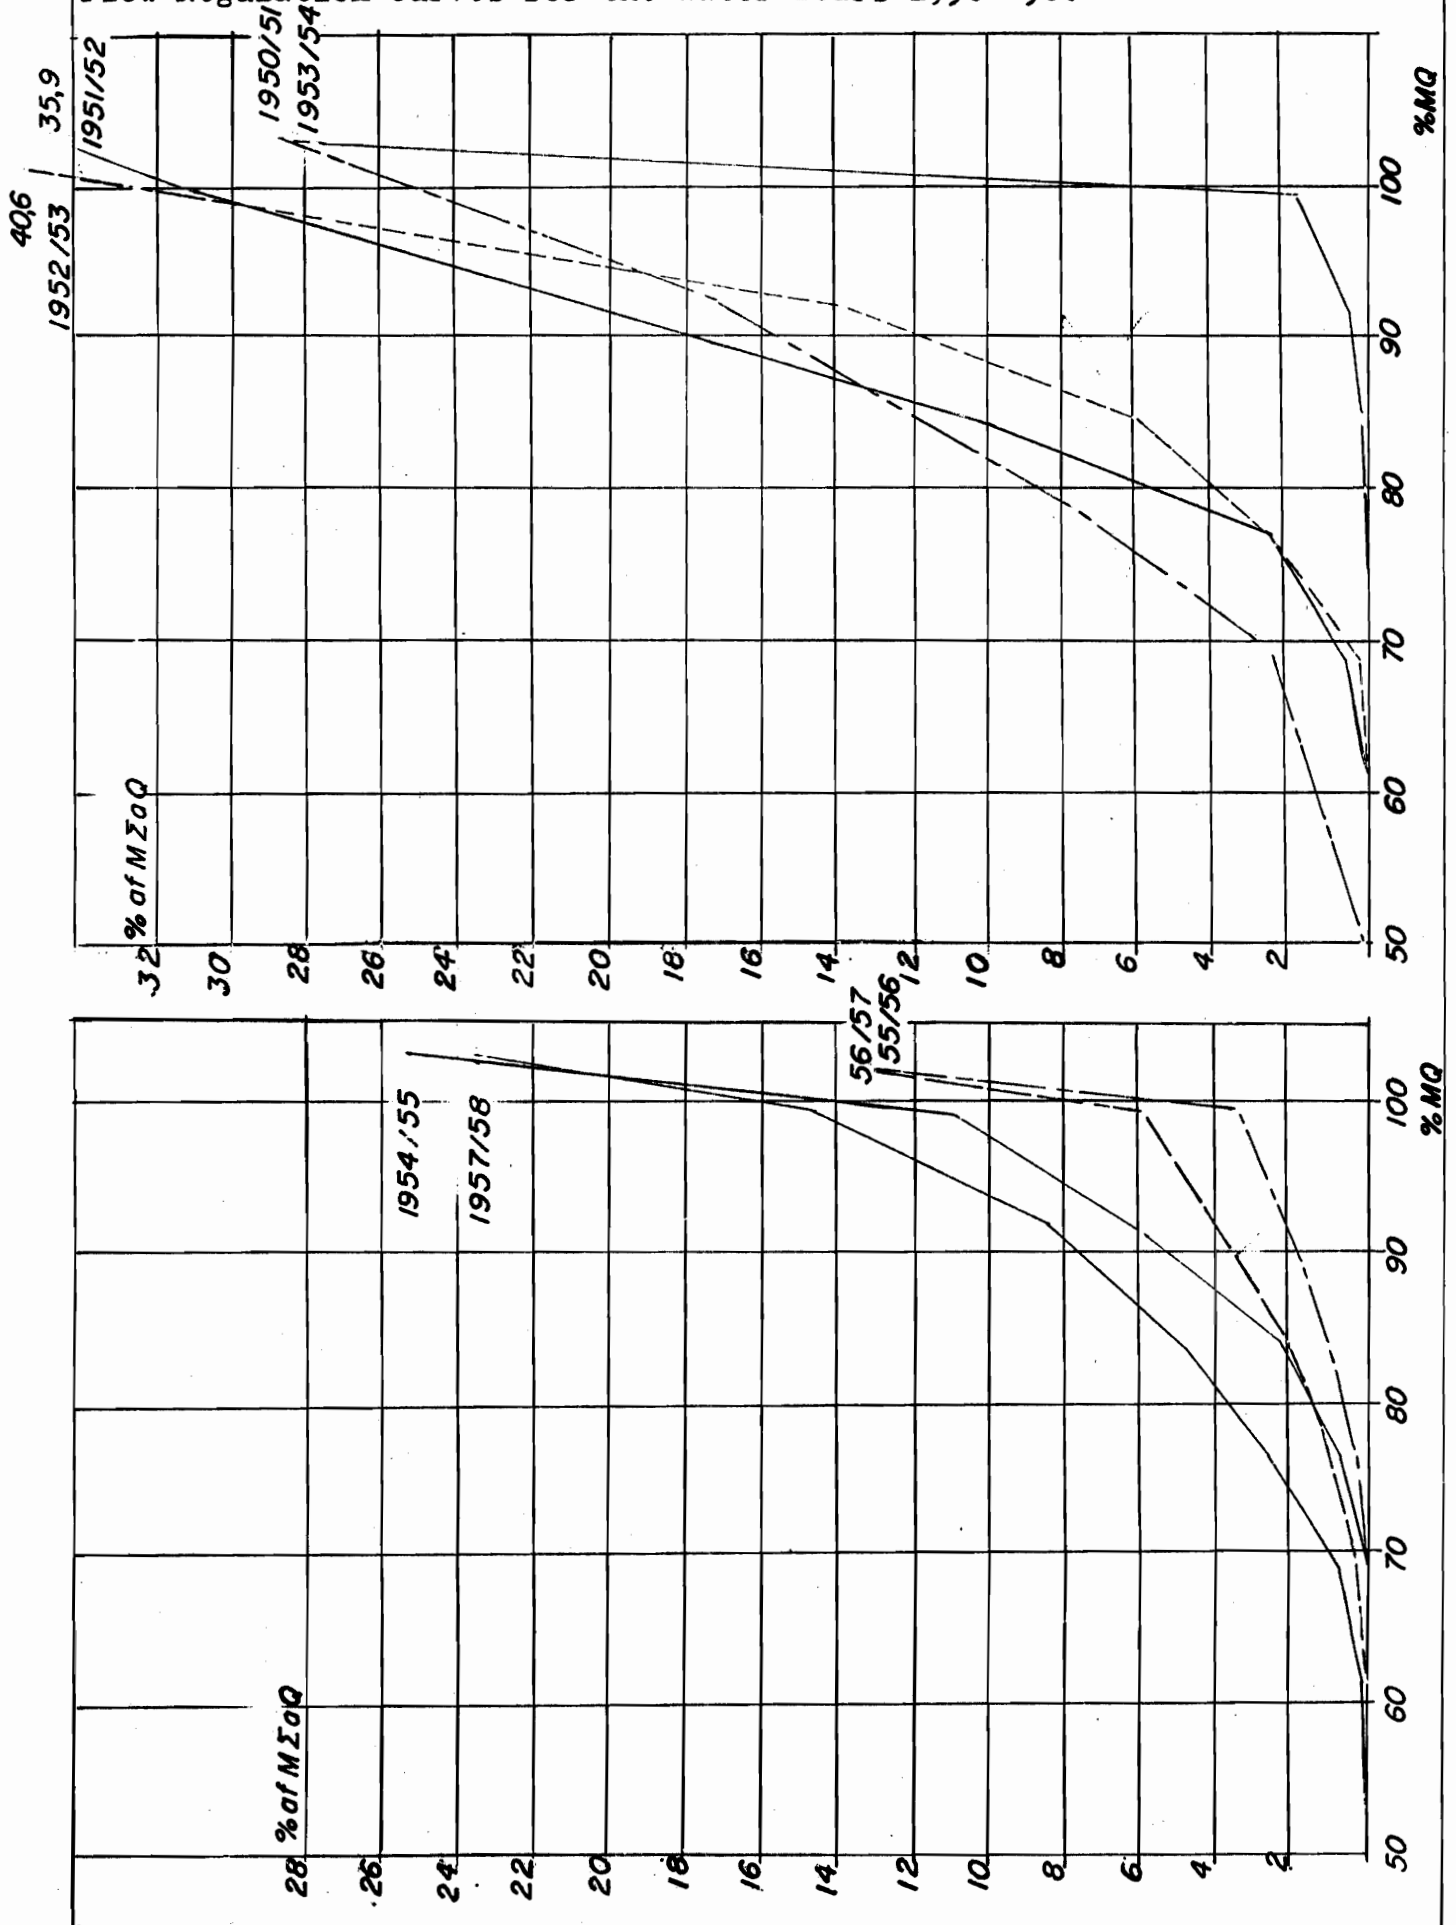
Flow Regulation Curves for the Water Years 1950-'58.

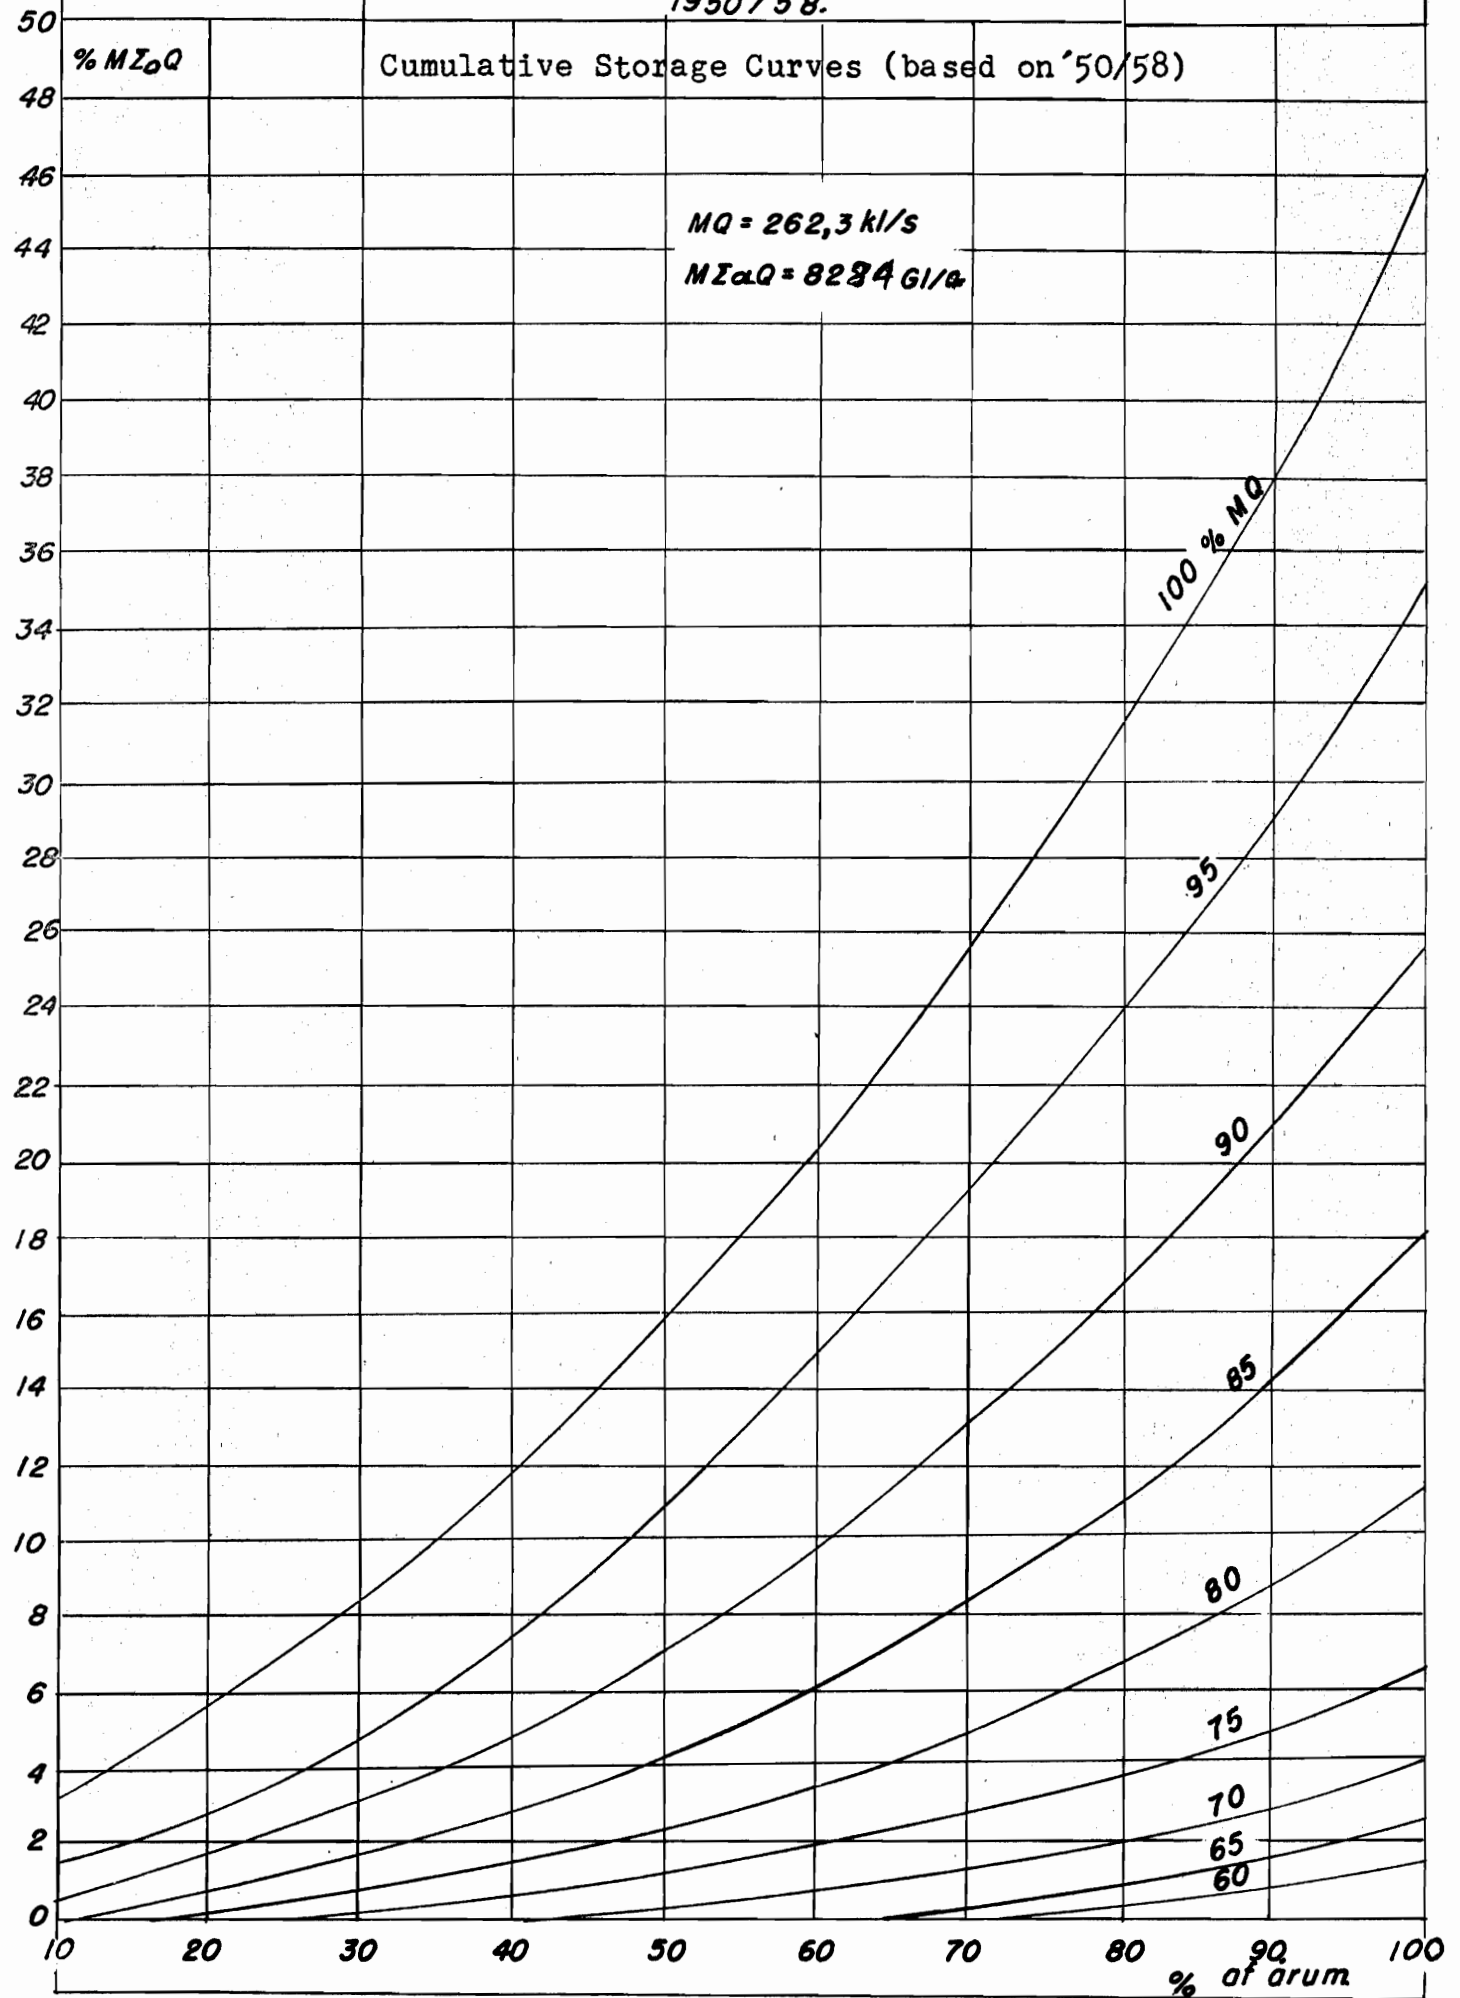
Mynd
Fig. 2-10

Cumulative Storage Curves (based on '50/58)

$MQ = 262,3 \text{ kl/s}$

$MZ_{0Q} = 8284 \text{ GI/Å}$

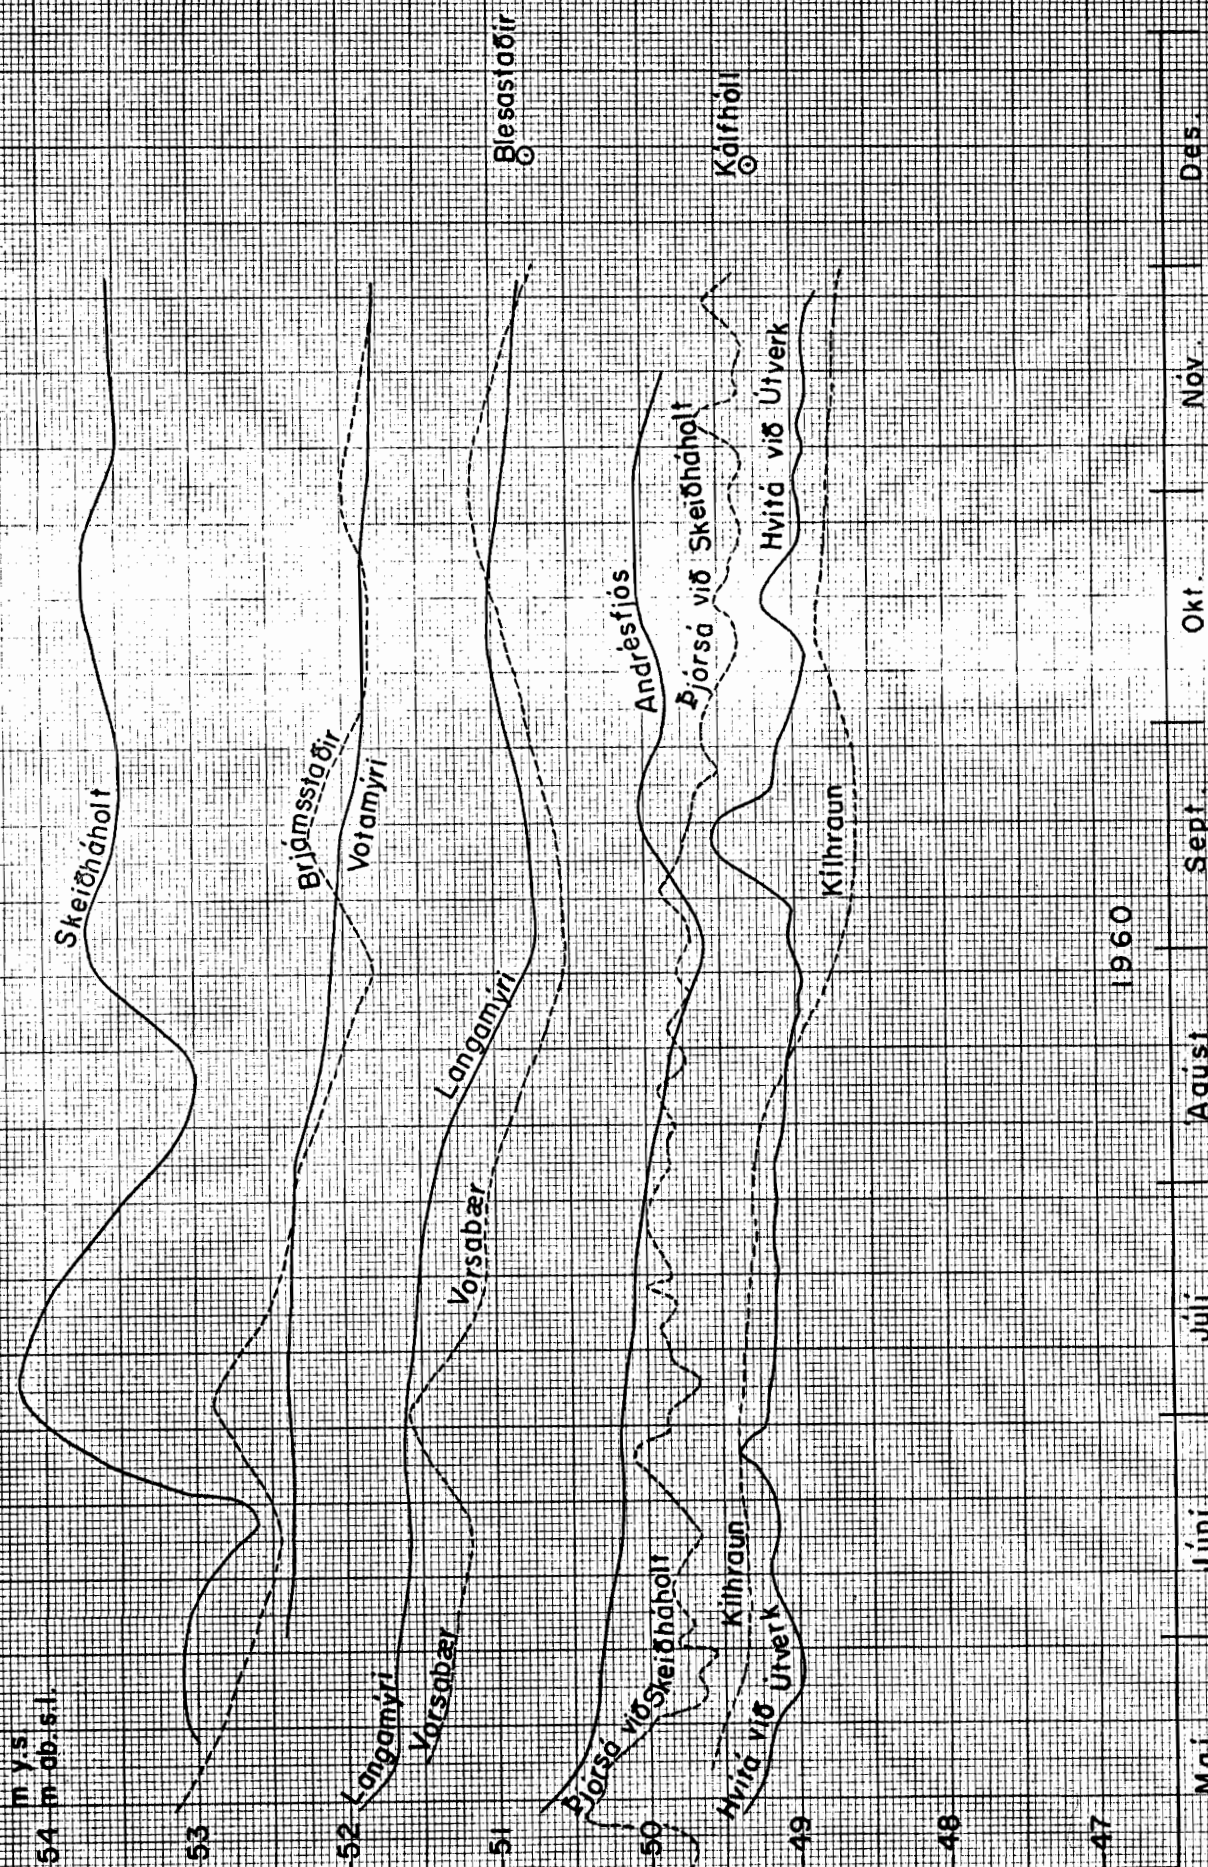
GRUNNVATN Á SKEIÐUM
GROUND WATER SURVEY EAST OF RESER-
VOIR AREA. Hydrographs

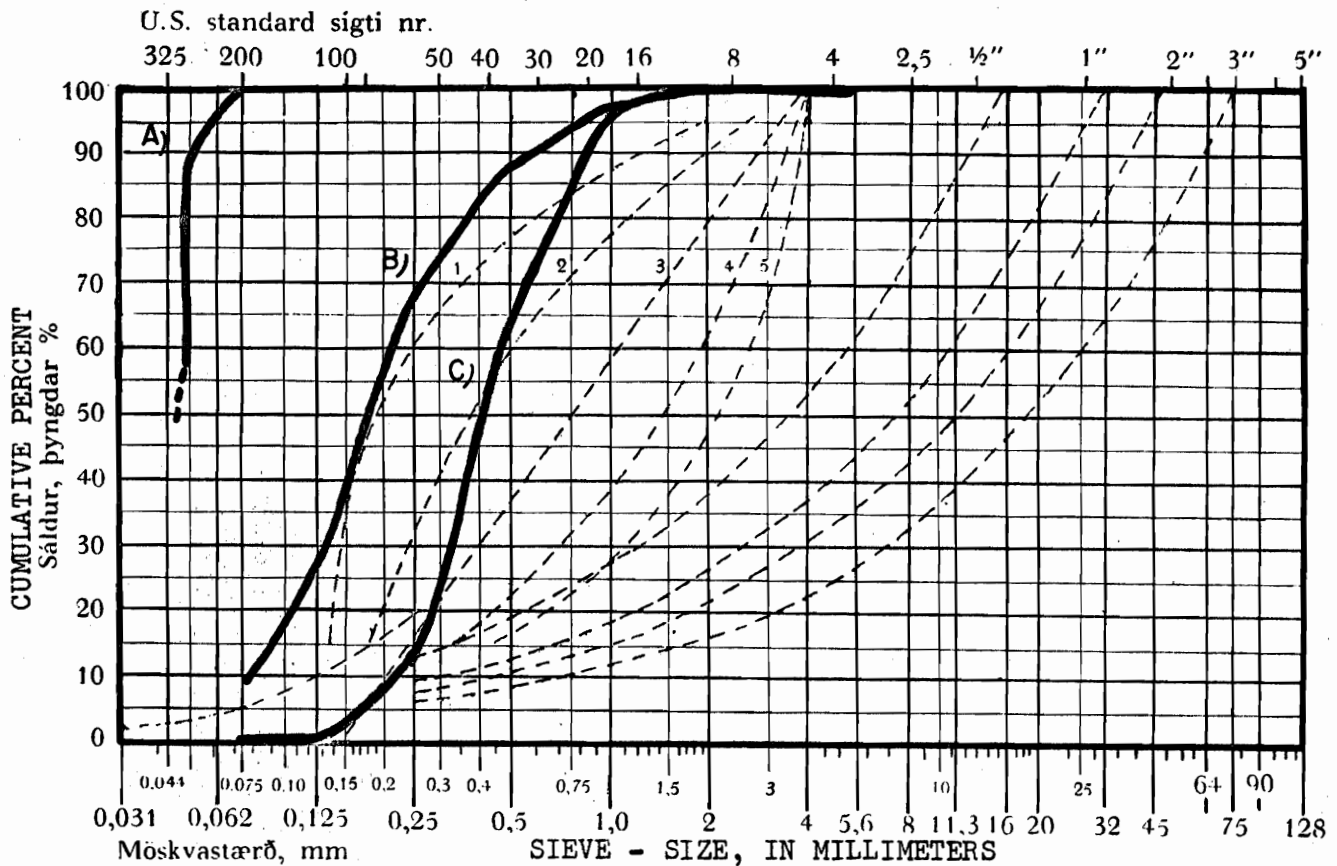
Rannsókn á kornastærðum.

Graphs showing particle-size distribution

HVÍTÁ, ÁRHRAUN 1. SEPT. 1960

- A) Sýnishorn af útfellingu í kyrrstæðu vatni, tekið úr botni viksins við vinstri bakkann milli V-1 og V-2.
A sample of deposit taken from the bottom of still water in the creek into the left bank between V-1 and V-2.
- B) Sýnishorn úr botni þversniðs V-1 150 m frá V-1.
Sample from the bottom of cross section V-1 150 m from the bench mark V-1.
- C) Sýnishorn úr sandeyri nál. miðri Hvítá undan Bauluósi.
Sample from a sandbank in the middle of River Hvítá near Bauluós.

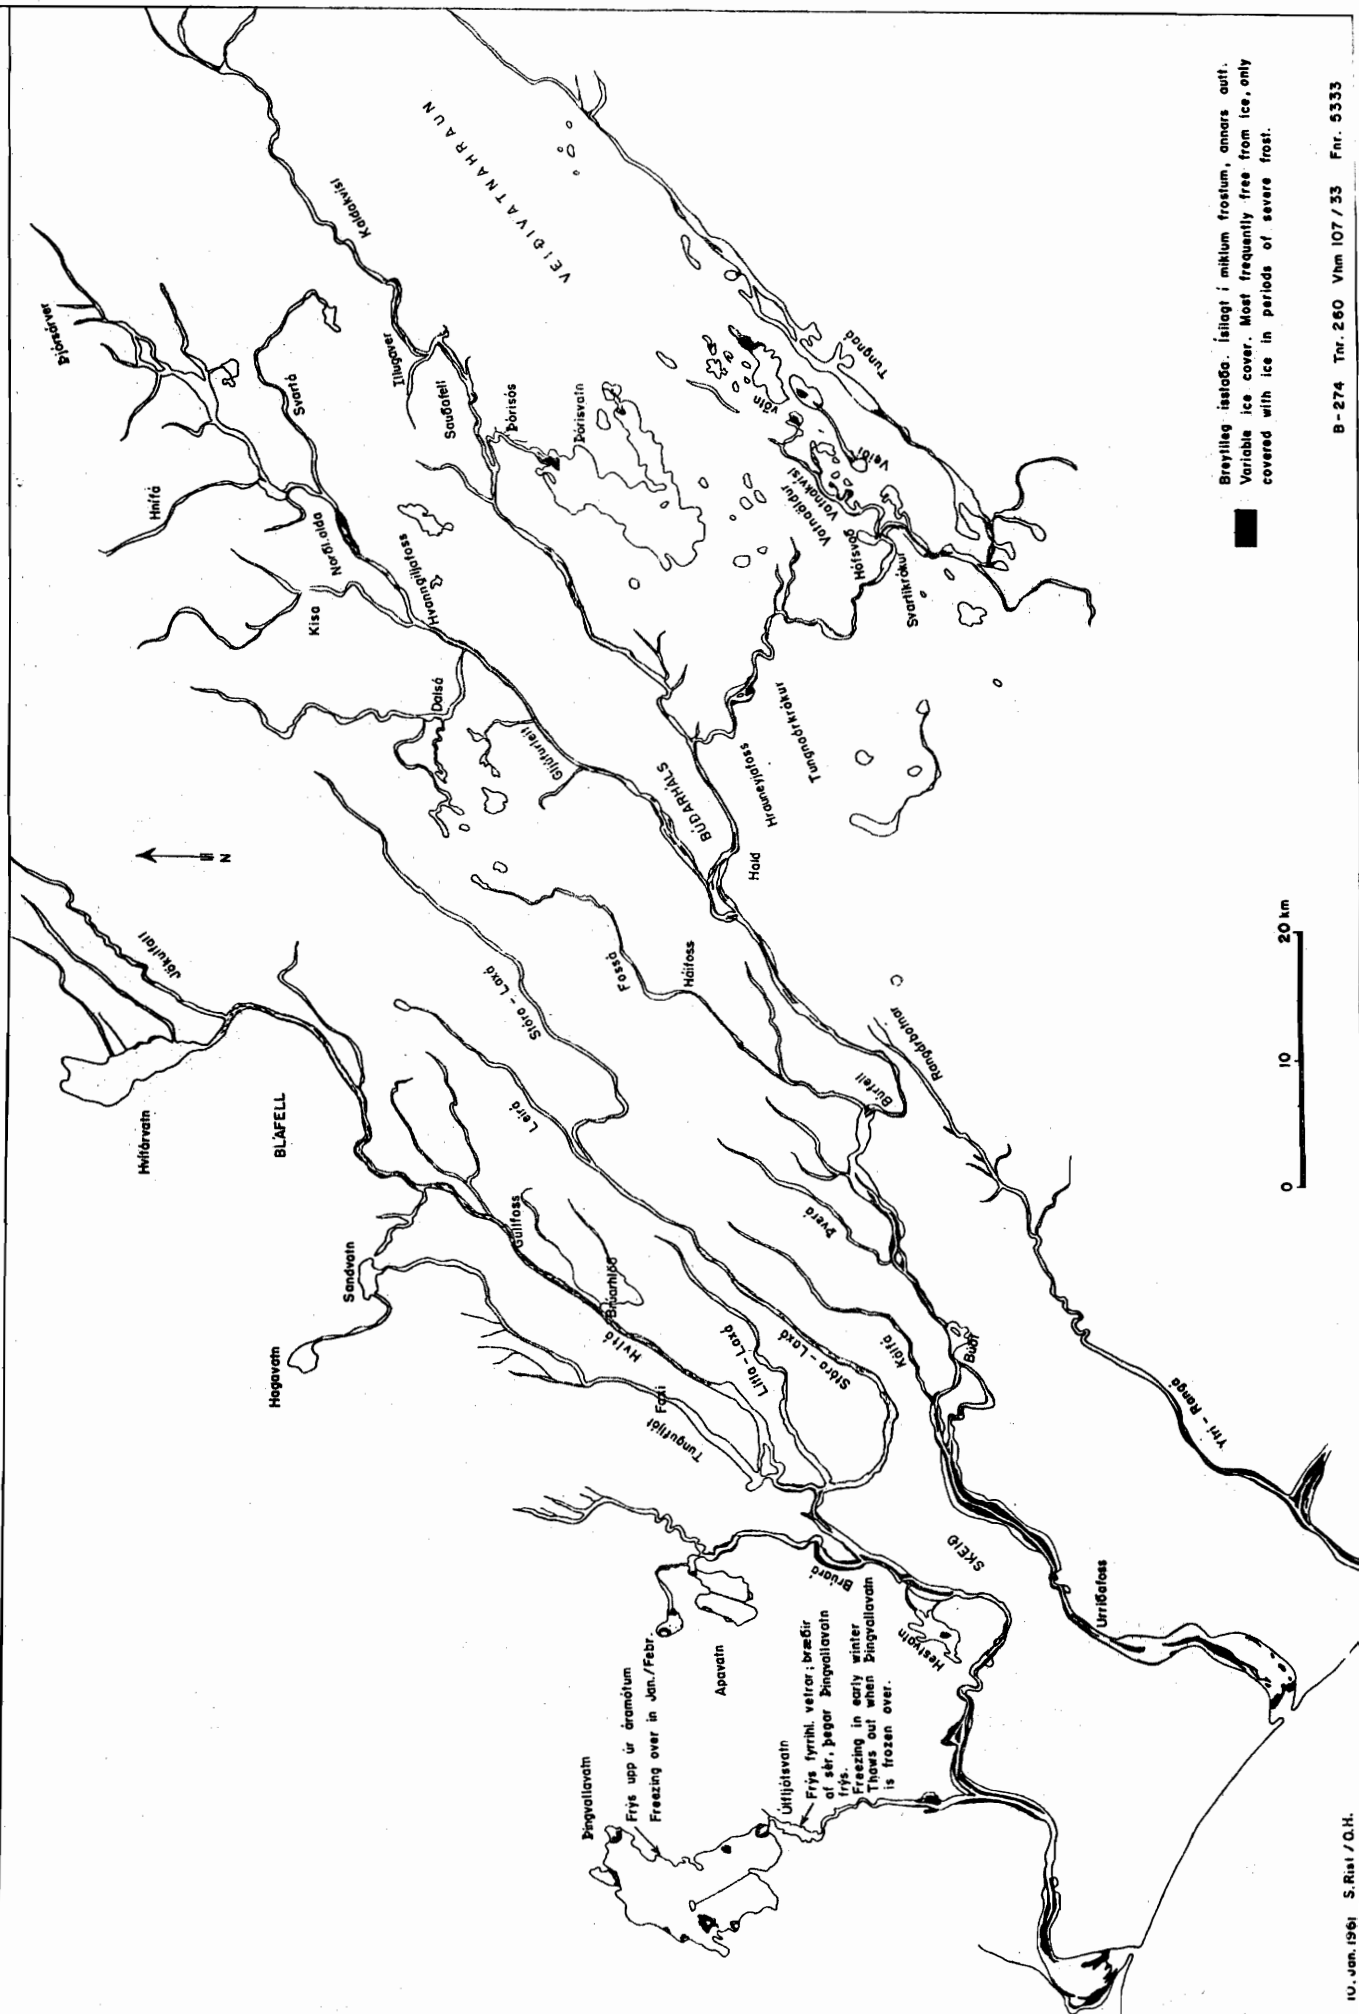
MYND 2-15 b
FIGURE

ISALÖG HVÍTA OG ÞJORSAR UM MIÐJAN VETUR
ICE CONDITION USUALLY PREVAILING IN THE ÞJÖRSÁ AND HVÍTA RIVER SYSTEMS
IN THE MIDDLE OF THE WINTER

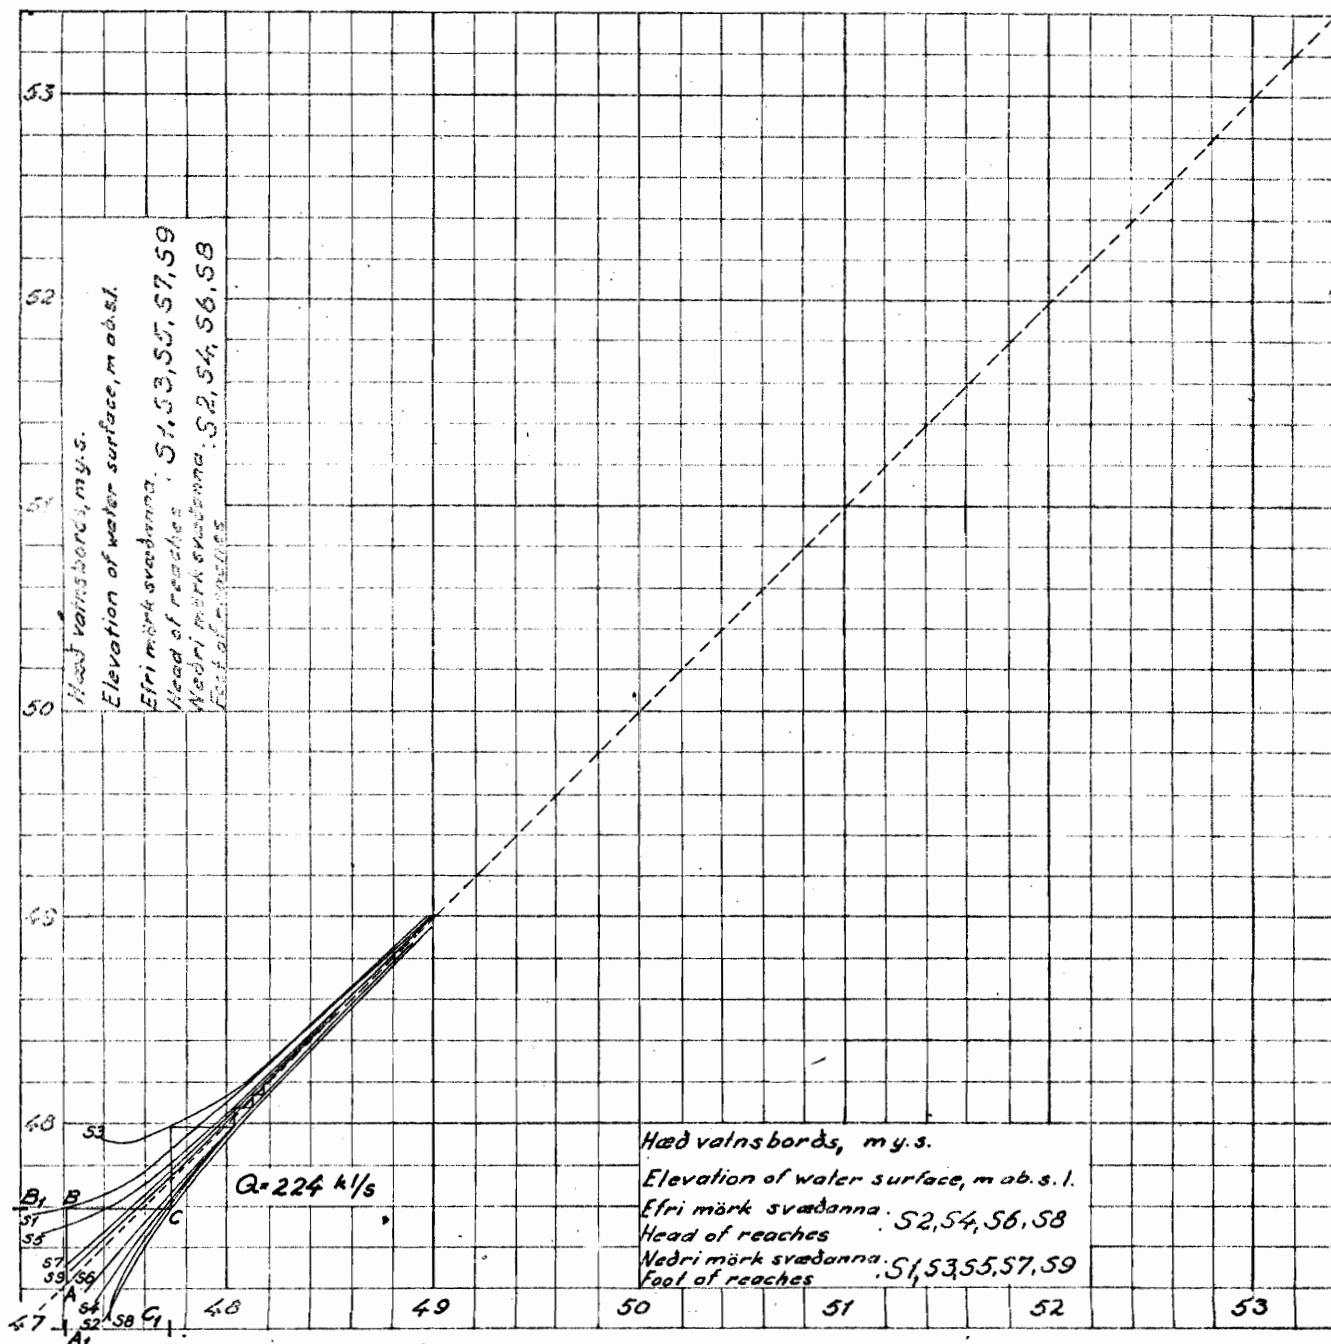
Mynd
Fig. 2-16

Stítt, Áhræðni
Dukvalnslínur $Q=224 \text{ kl/s}$
Backwater curves

Example:

Let the foot elevation of reach S1 be A (on the horizontal scale). Then the head elevation of reach S1 is B (on the vertical scale), which is also the foot elevation of reach S2, whose head elevation is then at C (horizontal scale) etc.
