HESTVATN HYDRO-ELECTRIC PROJECT

HYDROLOGICAL REPORT

SIGURJÓN RIST

Reykjavík, July 1961

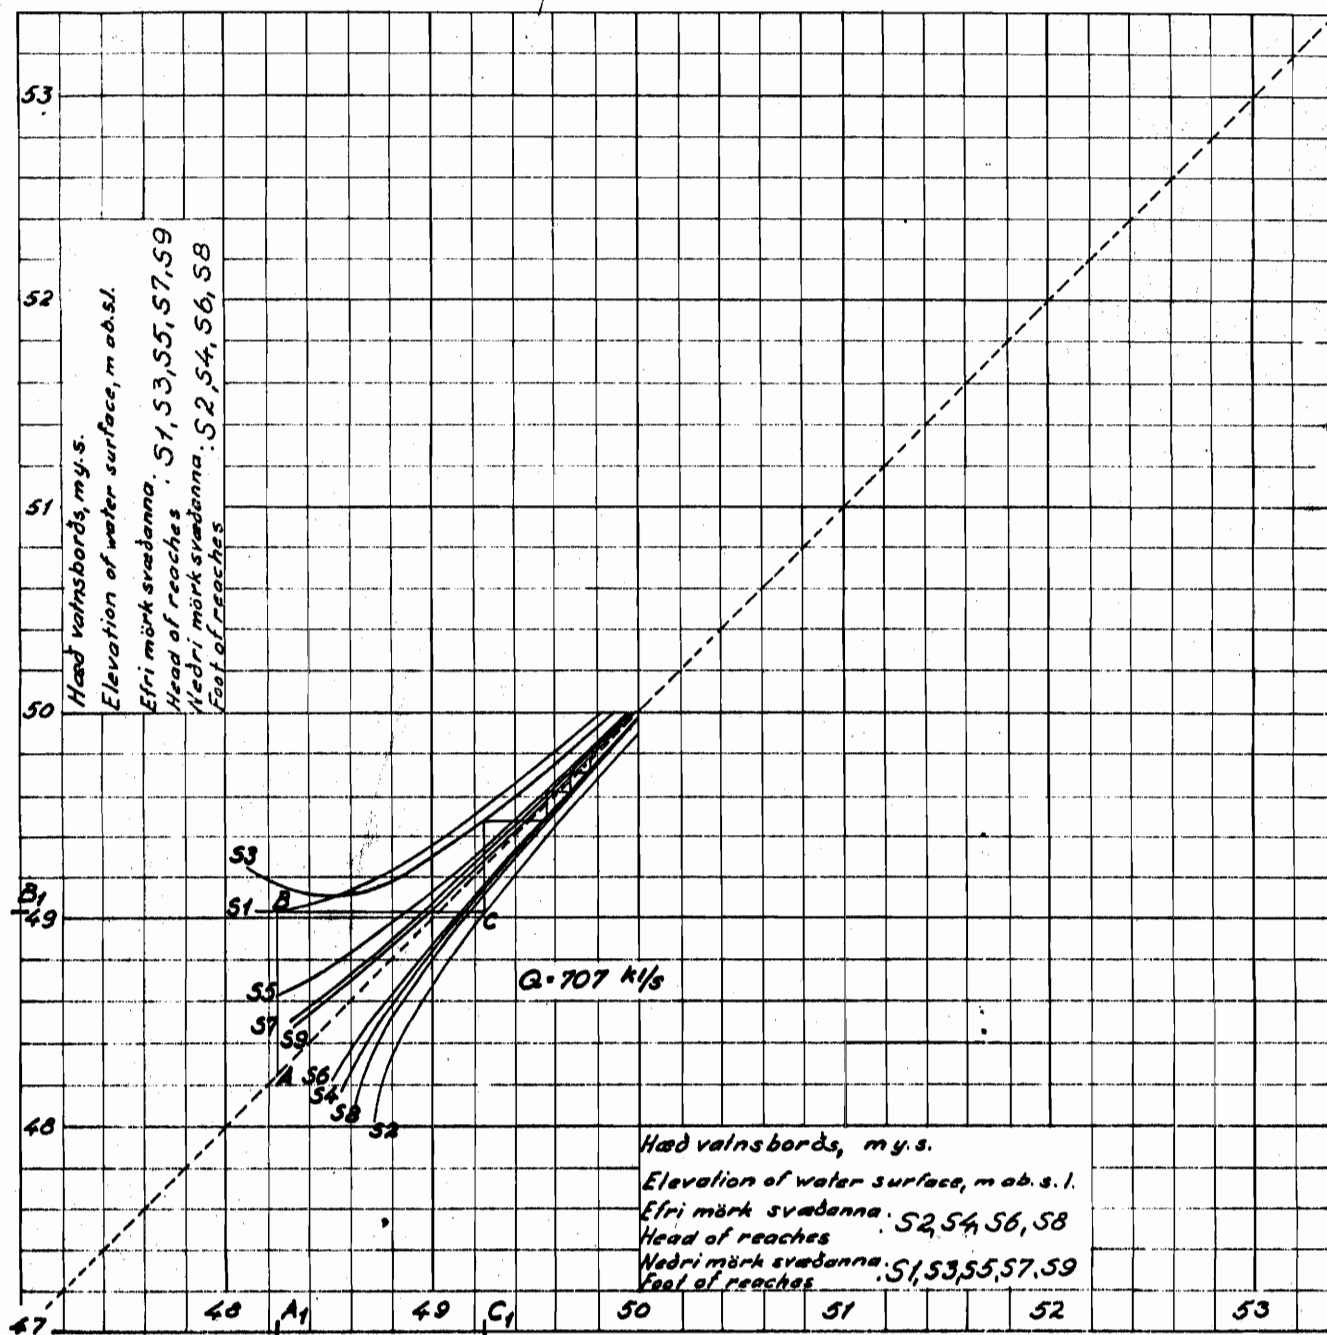
Mynd
Fig. 2-17

Hvítá, Áhrúun
Bakvatnslínur $Q=707 \frac{k}{s}$
Backwater curves

Example:

Let the foot elevation of reach S1 be A (on the horizontal scale). Then the head elevation of reach S1 is B (on the vertical scale), which is also the foot elevation of reach S2, whose head elevation is then at C (horizontal scale) etc.

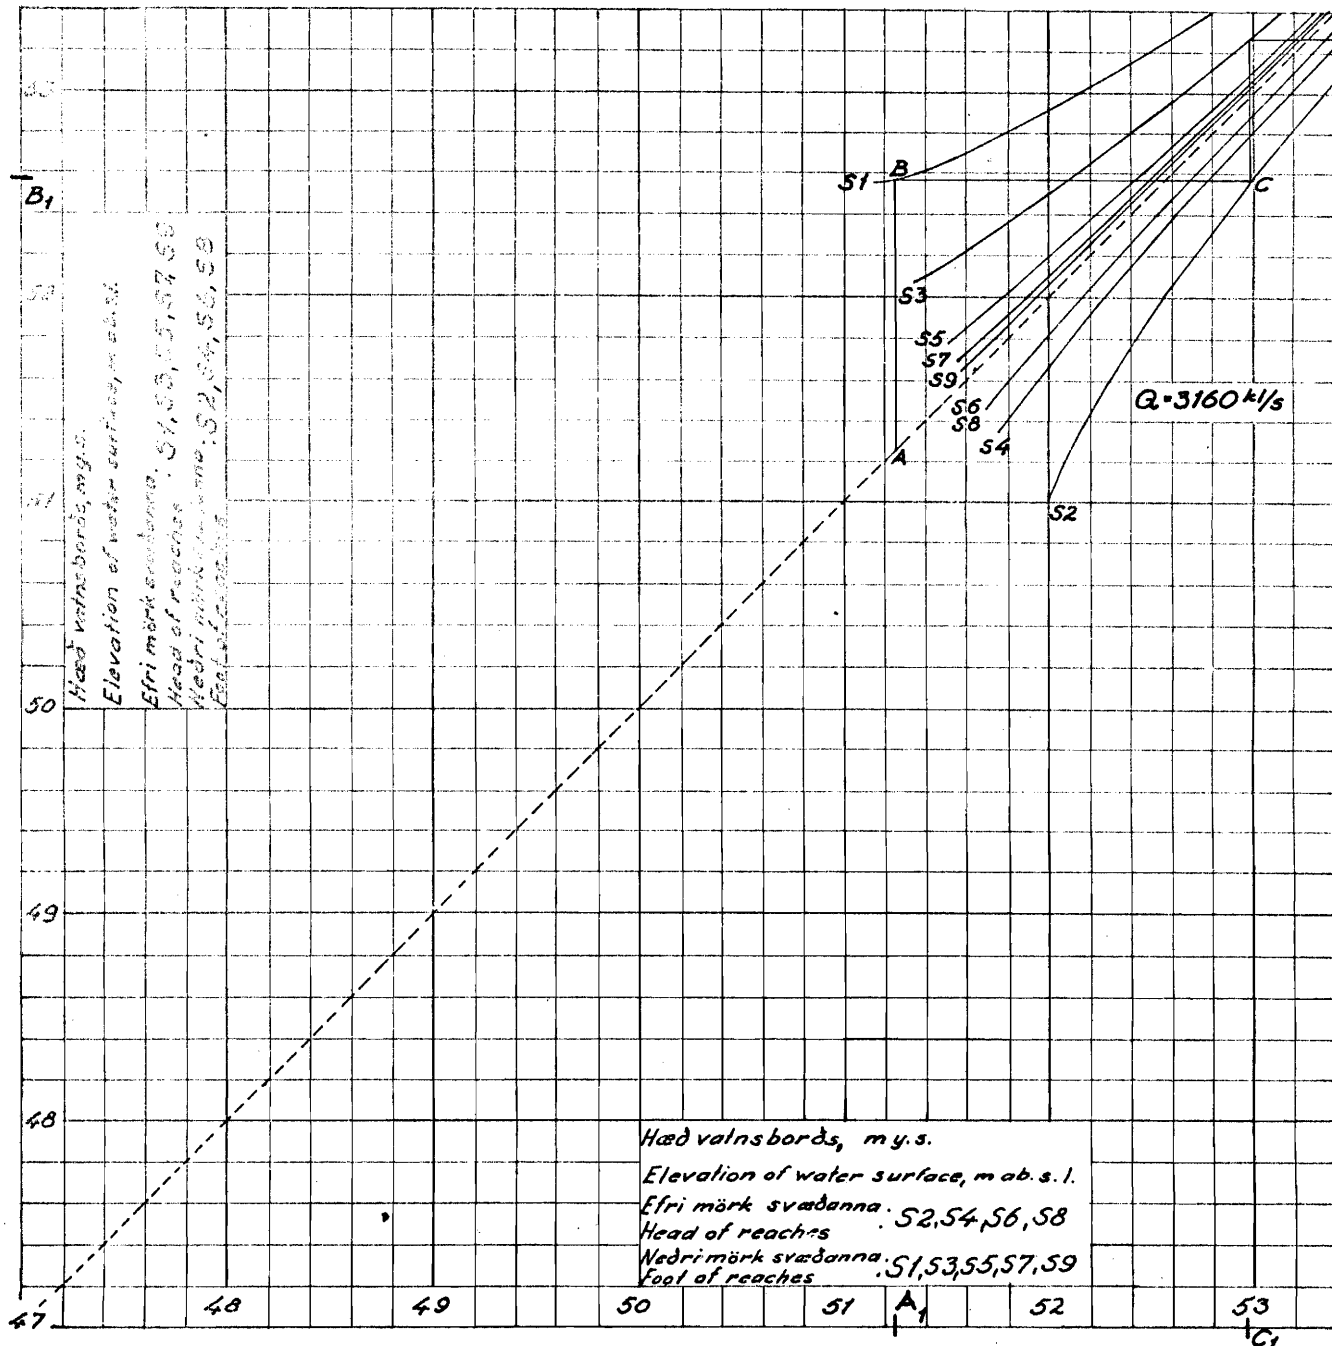
Mynd
Fig 2-21

R. G. Schmitt, Jr.	Hvítá, Arkhron	Q=3160 k1/s	1-200 5m/15,
Vakuumstinger	Bakvalslinur		Vhm. 107 Tnr. 26
	Backwater curves		B. 274 Tnr. 247
			Fnr. 5302

Example:

Let the foot elevation of reach S1 be A (on the horizontal scale). Then the head elevation of reach S1 is B (on the vertical scale), which is also the foot elevation of reach S2, whose head elevation is then at C (horizontal scale) etc.

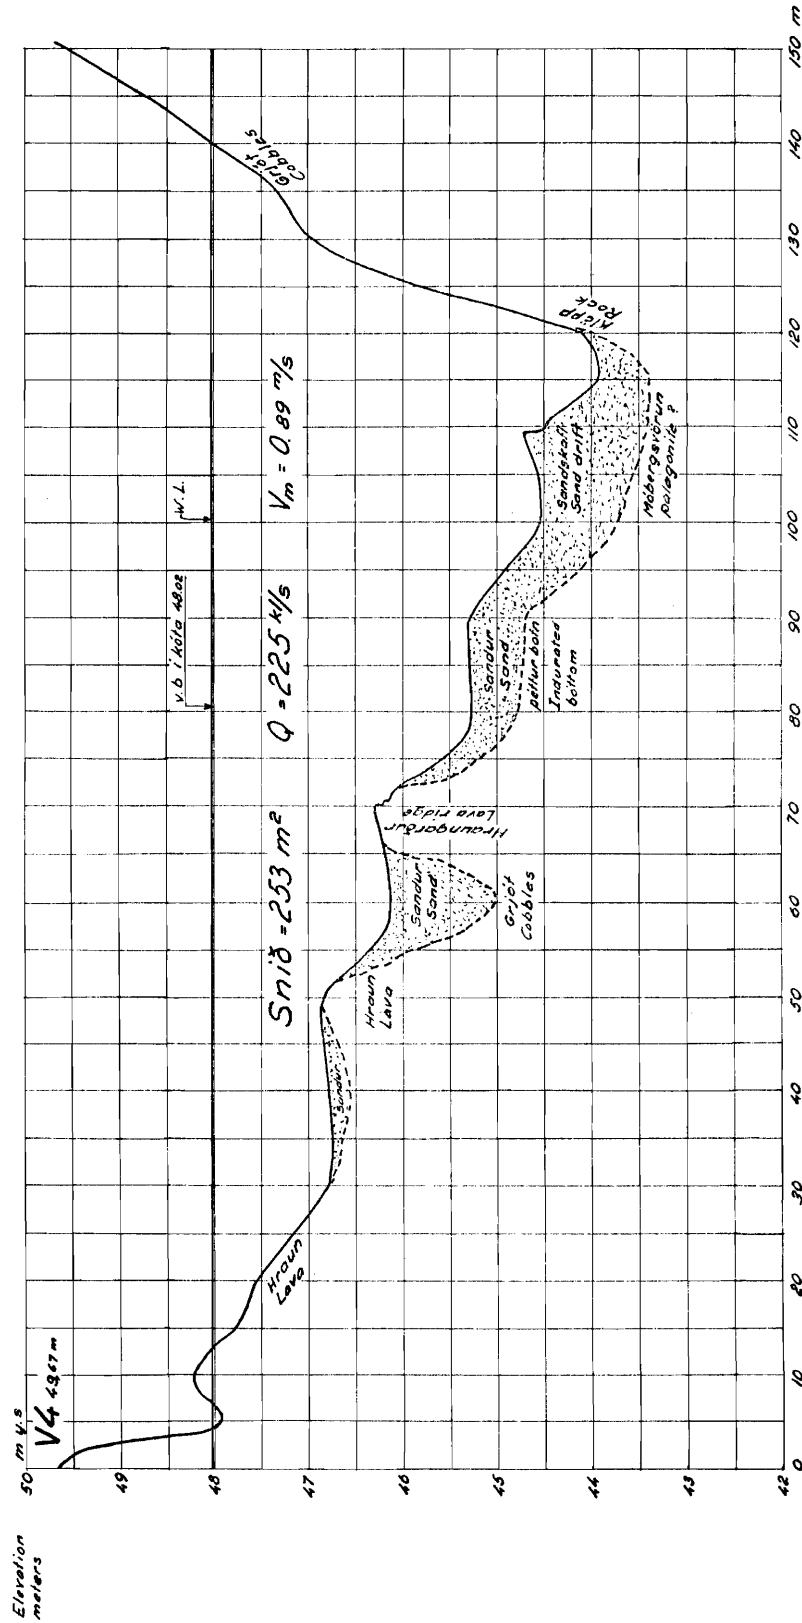
Þversnið V4

Cross section V4

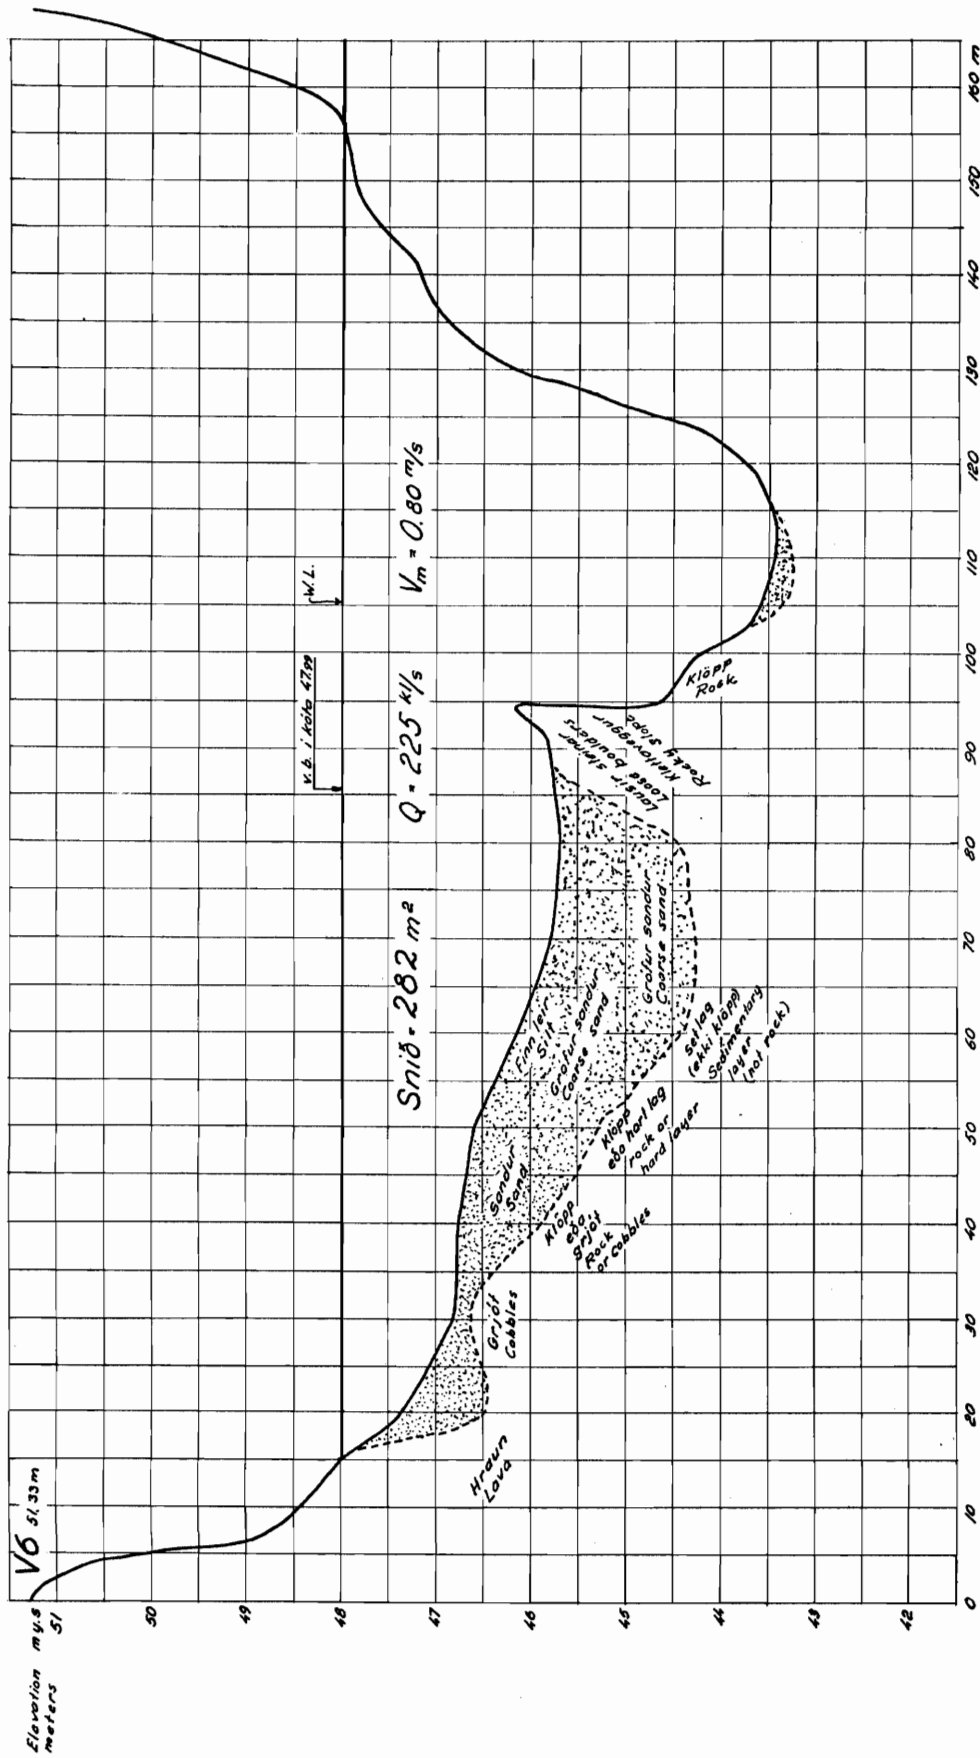
Översnidd Vö

Cross section V6

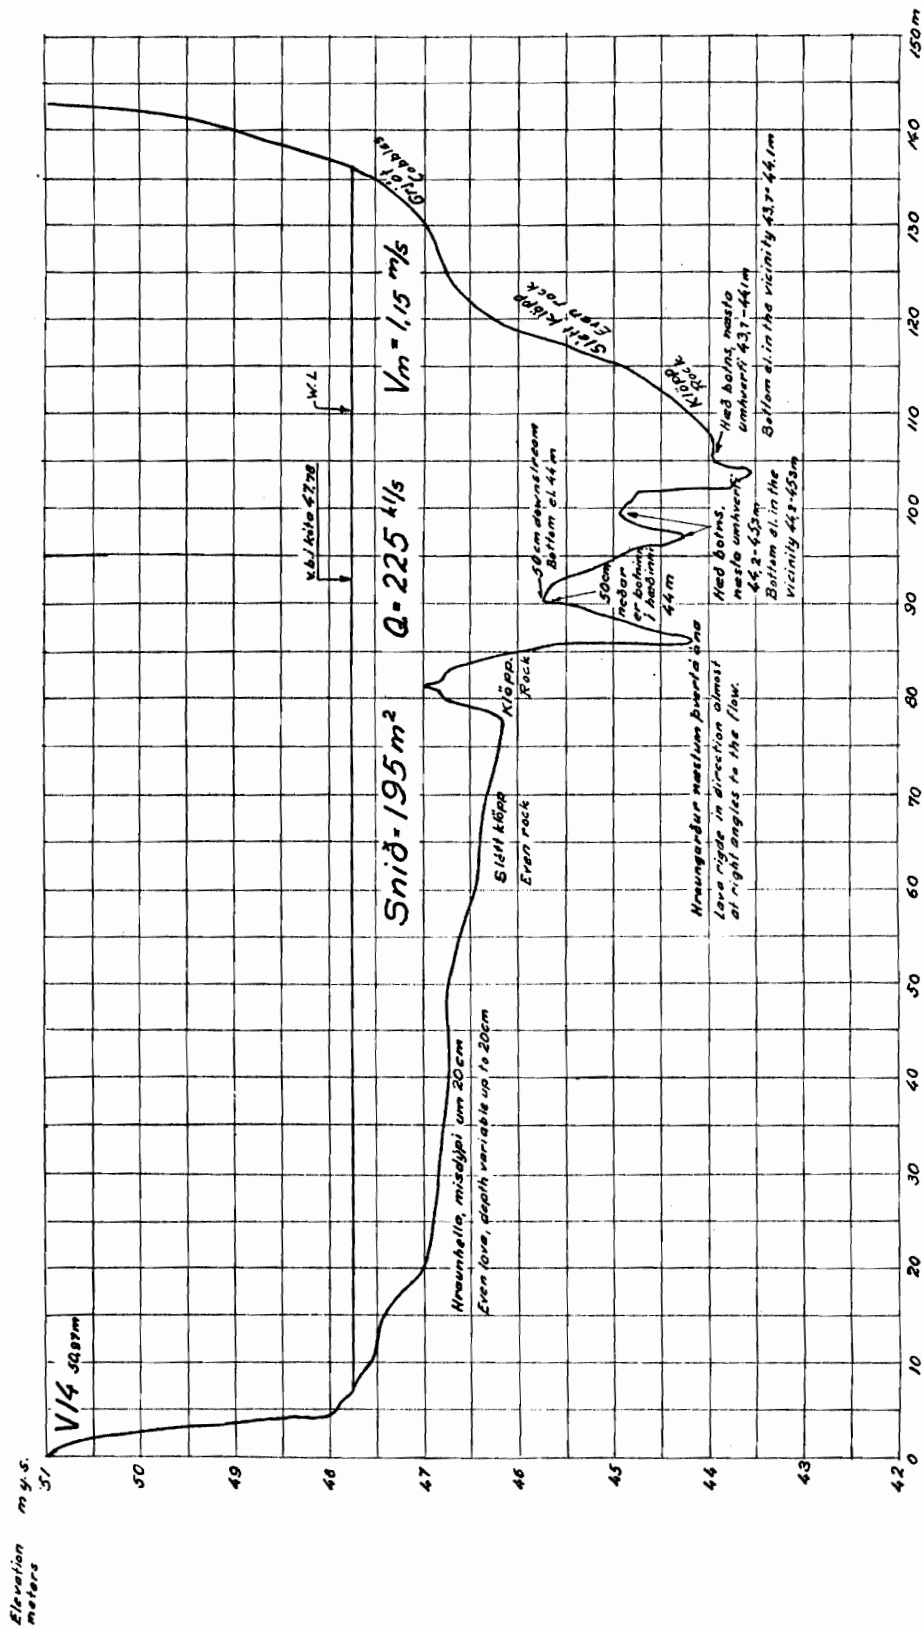
RA FORKUMÁLSTJÓRI	H=1:50	19/1205 R. Ryd. 10
	H=1:500	Vfm. 107 B274 T.221
Hvíti, Áhrhauð Þversnið V14 Cross section V14	Fnr. 5247

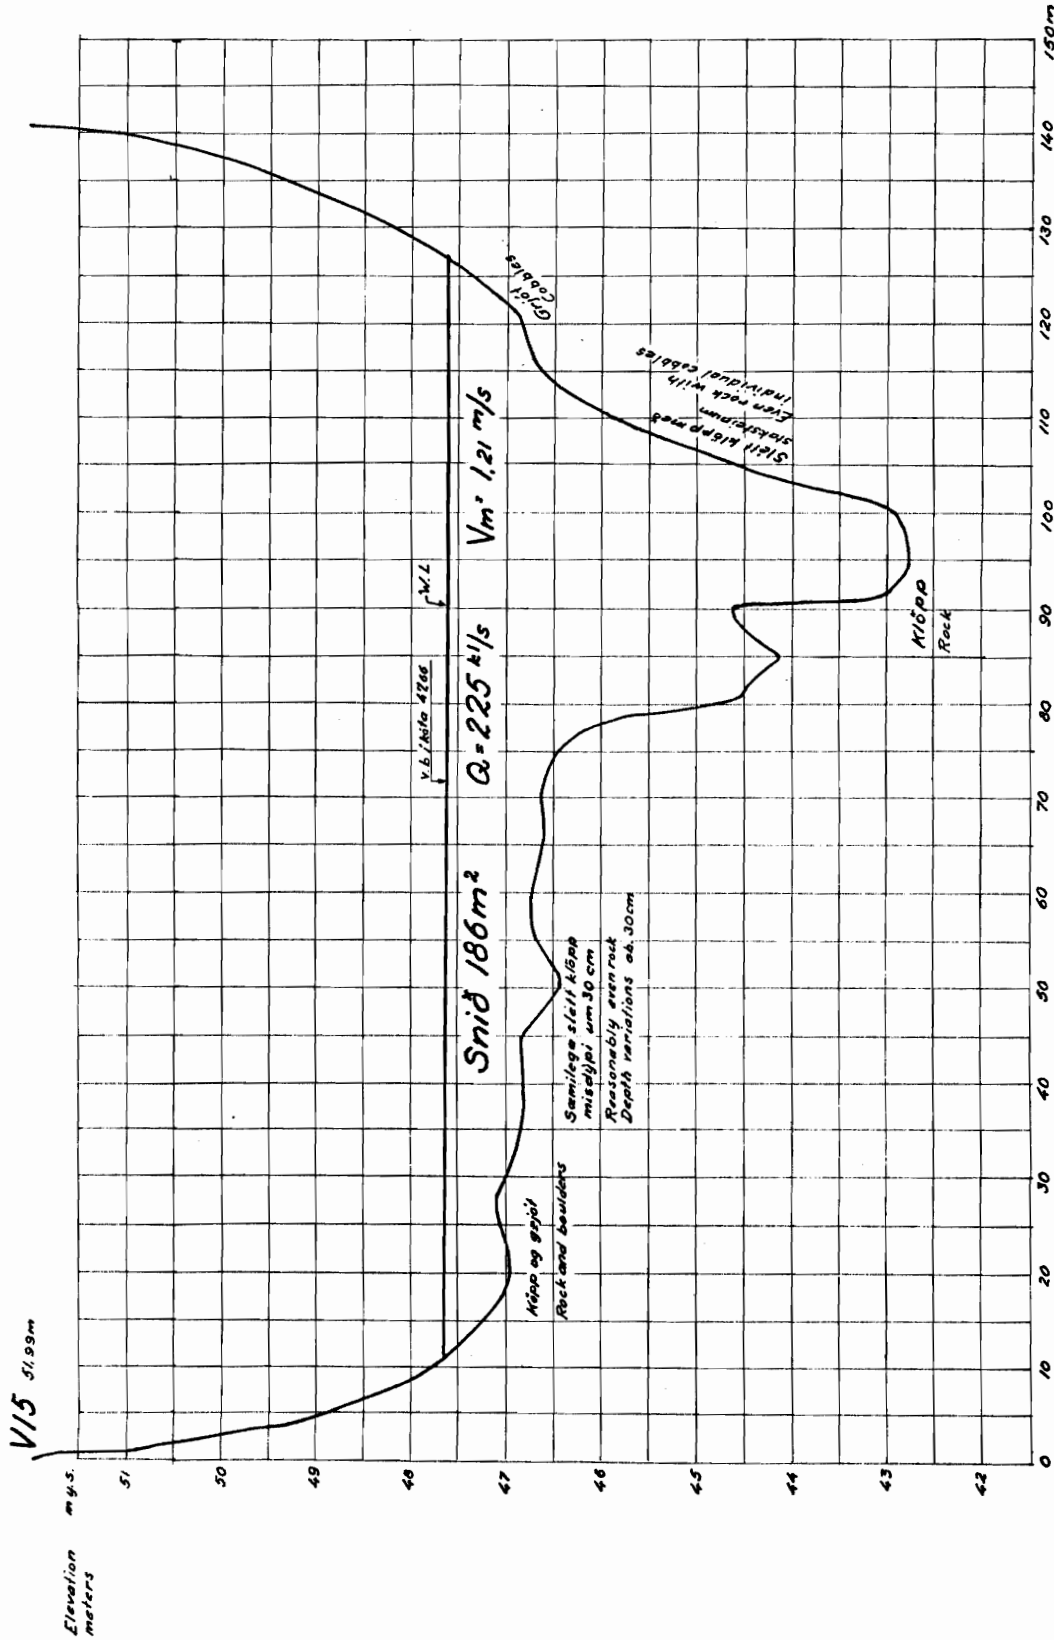
RAFORKUMALASTJÓRI			
Hvítá, Arhraun Þversnið V15 Cross section V15	H = 1:50	9/12/60 S. R. H. 18	Fr. 5248
	L = 1:500	V. H. m. 107	
			B 22% T 222

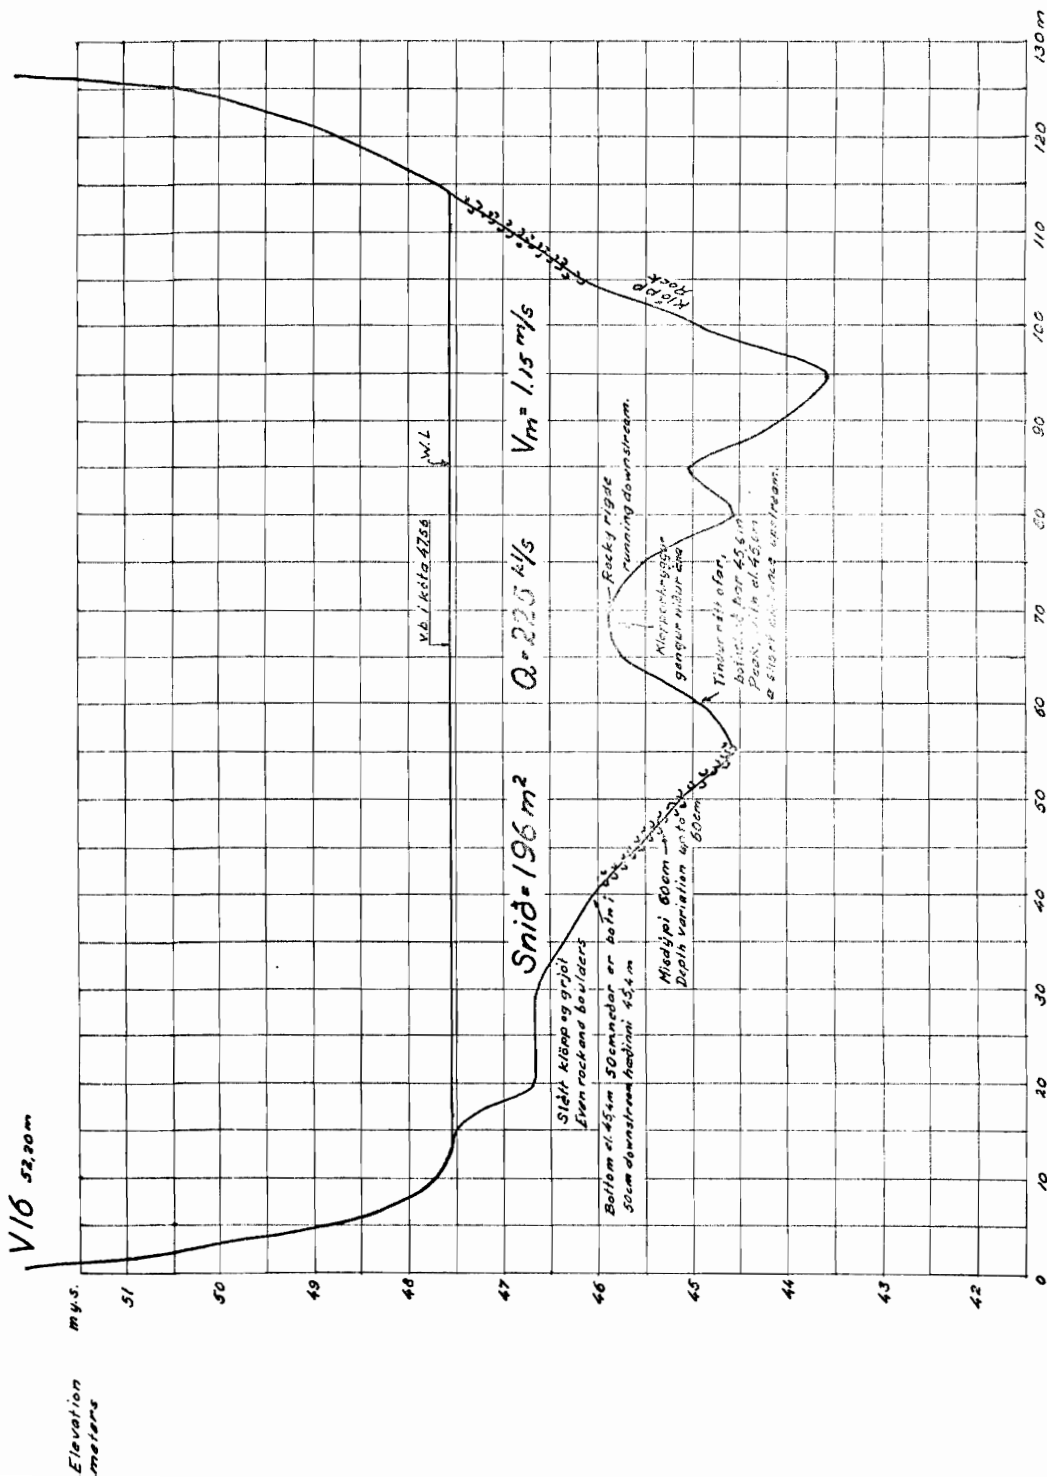
RAFORKUMALASTJÓRI		
Hvítá, Árhraun	H = 1:50	9/260 J. R. 1/2
	L = 1:500	Vhm. 107
Bærsmid V16		B274. T223
Cross section V16		Fnr. 5249

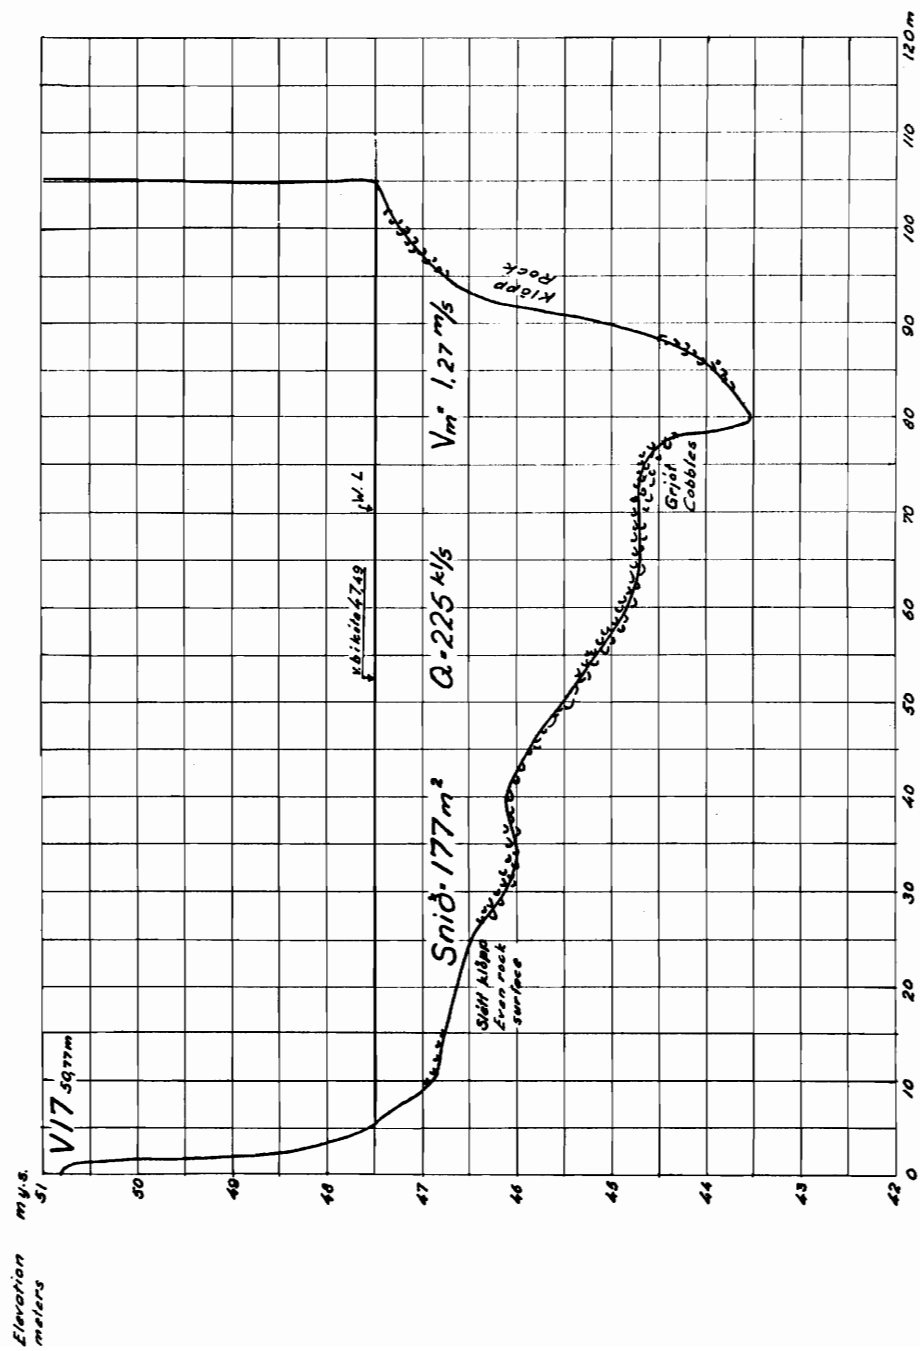
RAFORKUMÁLASTJÓRI		9/2 60 J. R. 13/18
Hvítá, Árhraun.	H = 1:50	Vhm. 107
	L = 1:500	B274 T.224
Þversnið V17		Fnr 5250
Cross section V17

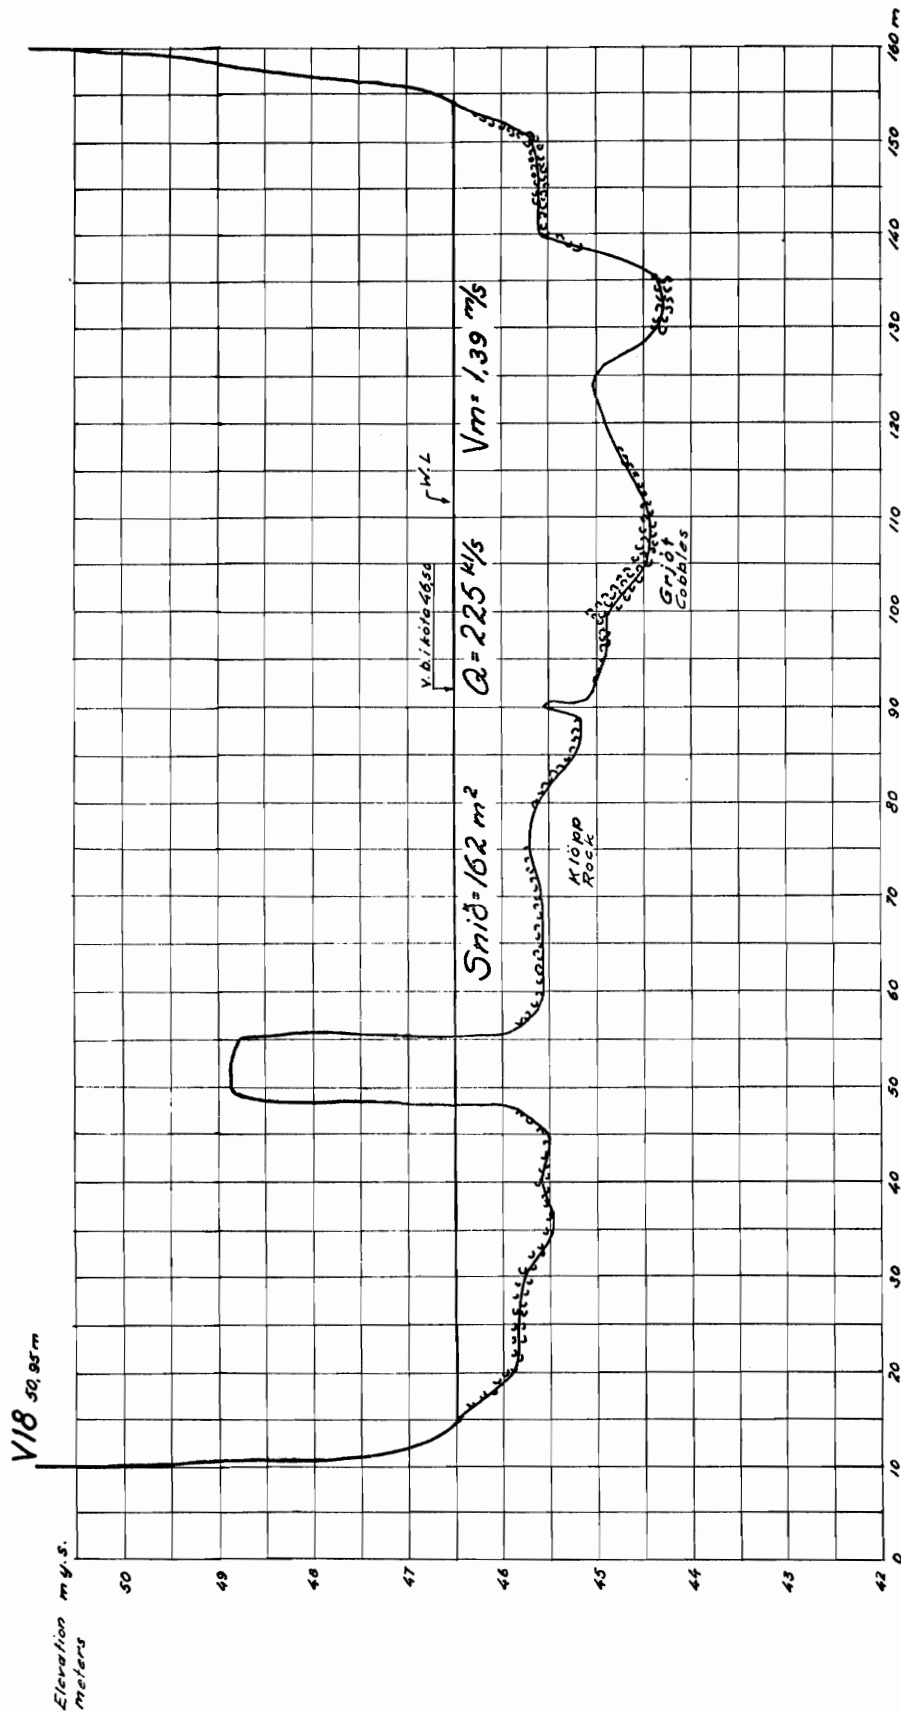
RAFORKUMALASTJÓRI	
H=1:50	19/12/60 S. Reykjavík
L=1:500	V/m. 107
	B276 T.225
Hvítá, Arhraun	
Þversnið V18	
Cross section V18	
Fr. 5251

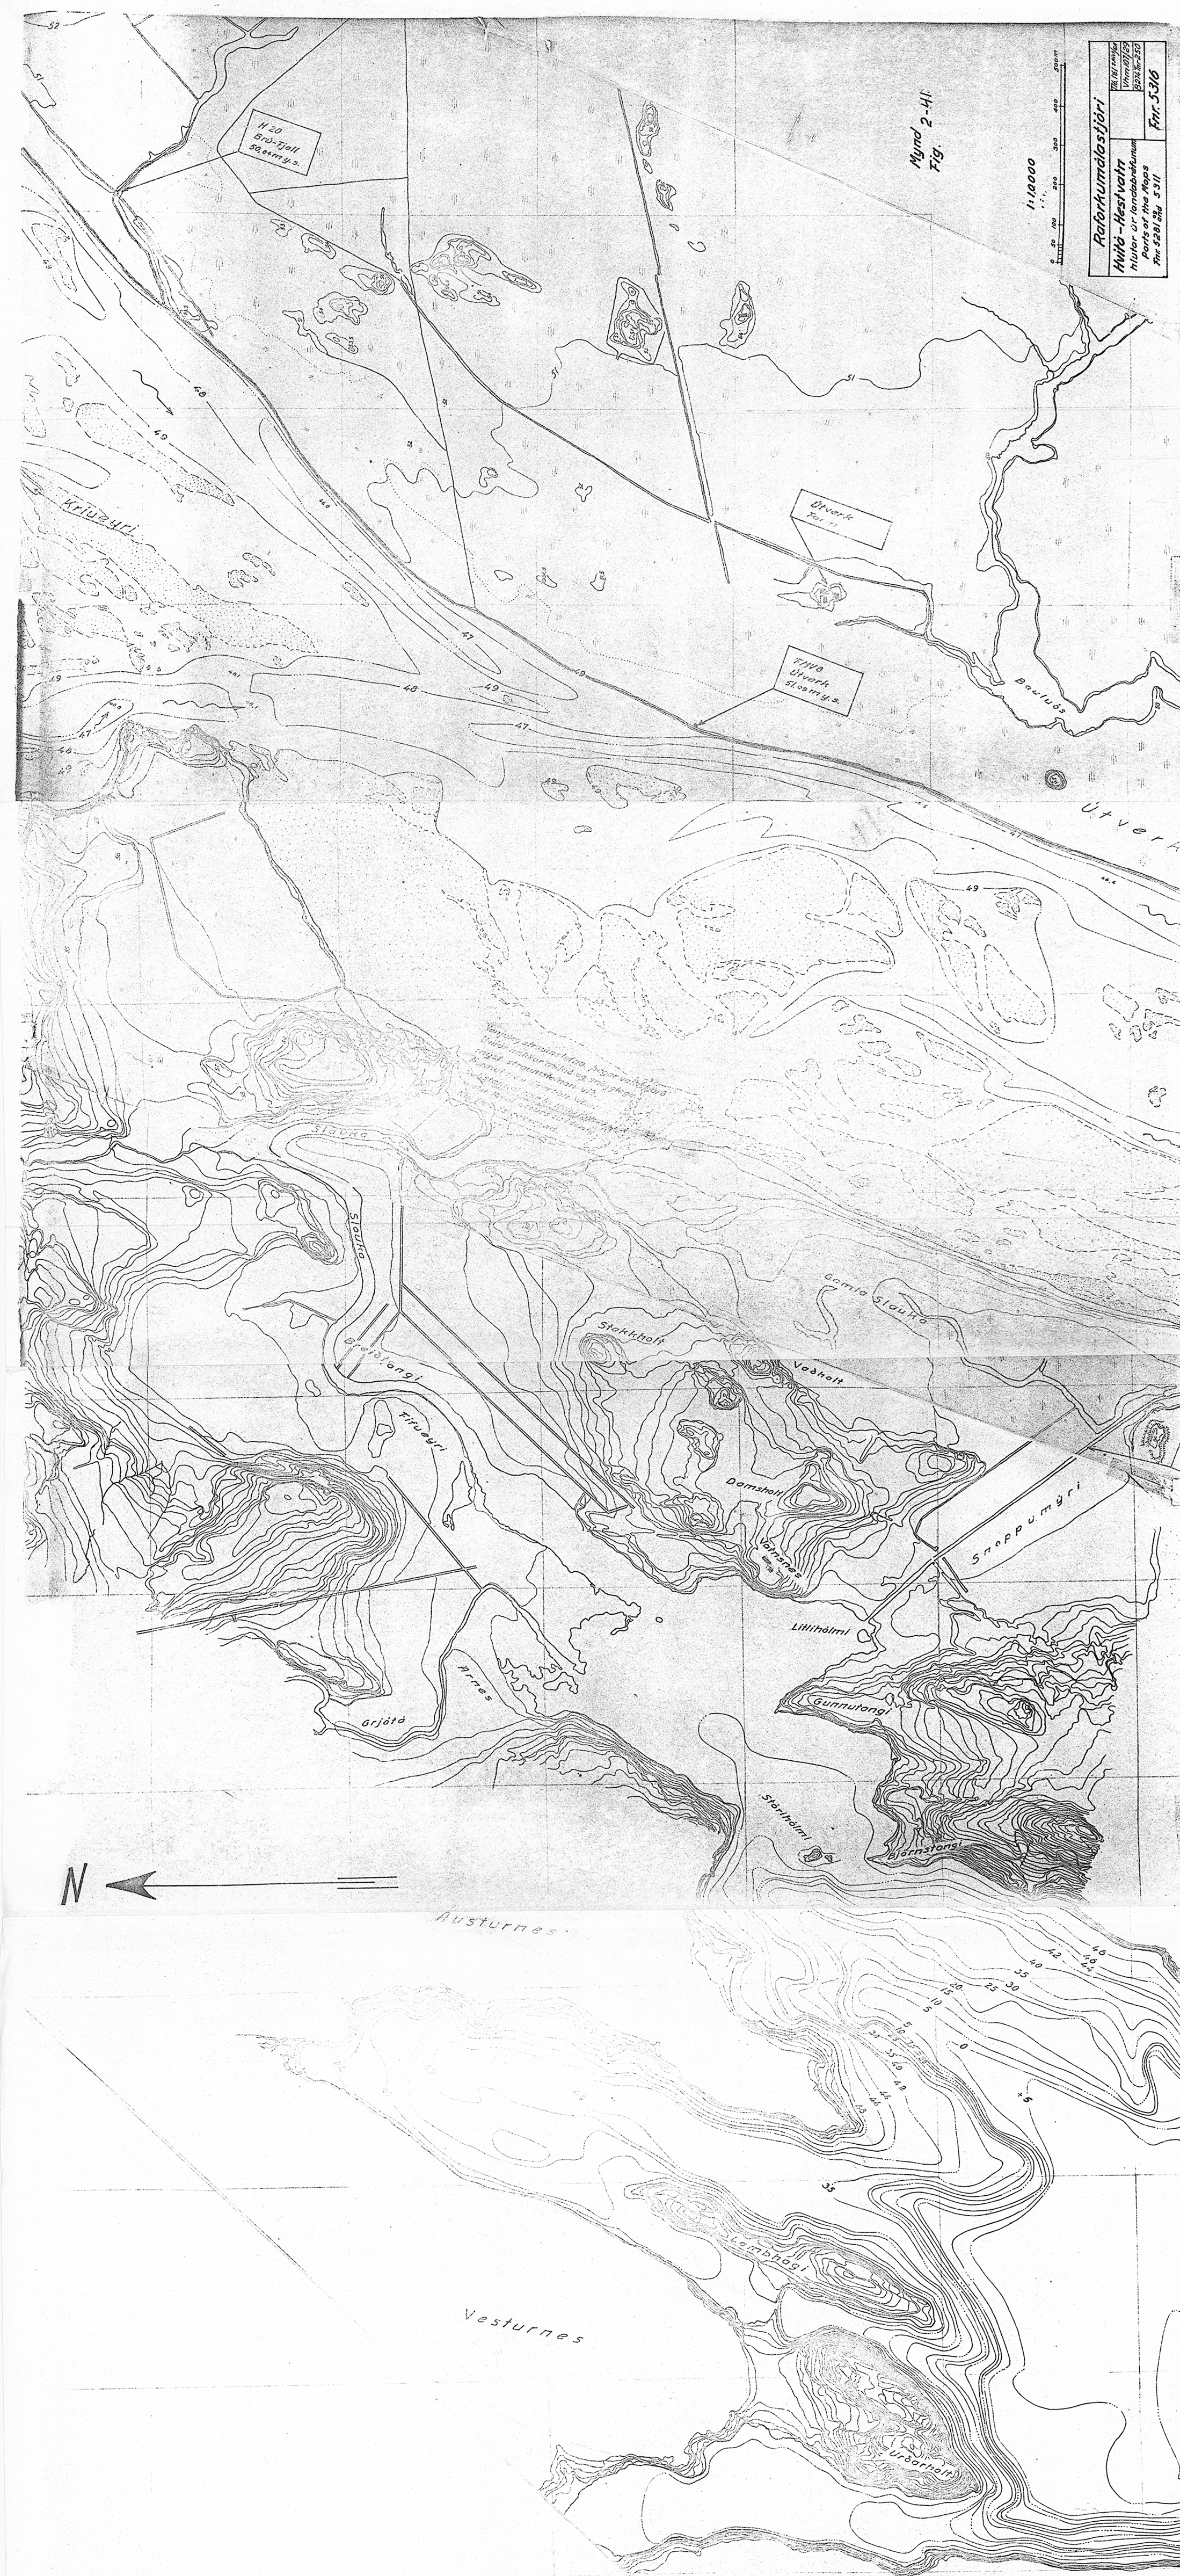
Grundvalloð á 43
vatnssýnishornum.
Based on 43
Water Samples
24. Feb. '56 - 24. Jun. '60

- 1) $\left\{ \begin{array}{l} 500 \times 10^3 \text{ kg} / 24 \text{ h} \\ 36,5 \times 24 \text{ h} \end{array} \right\} 1825 \times 10^4 \text{ kg}$
- 2) $\left\{ \begin{array}{l} 10^7 \text{ kg} / 24 \text{ h} \\ 3,65 \times 24 \text{ h} \end{array} \right\} 365 \times 10^5 \text{ kg}$
